## CASE STUDY

# PHOENIX AREA STORMWATER TANK RESTORATION

Chandler, AZ Stormwater Tank

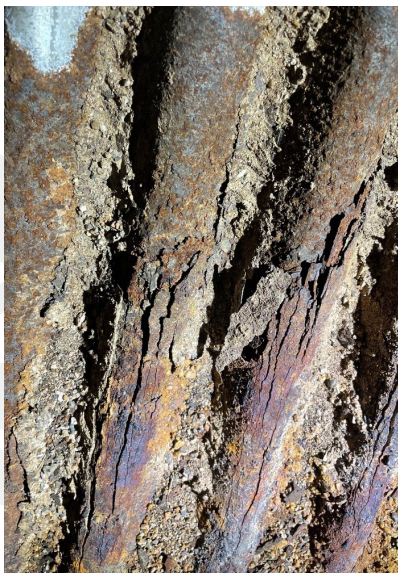
A commercial business used a buried 96" tank made of corrugated metal pipe for stormwater management, but water pooling in the corrugations had rusted the bottom and exfiltrated, leaving voids in the sandy soil beneath. As the tank shifted downward, it created dips in the parking lot above. In extreme cases, similar damage can lead to surface collapse.

*Closeup of the decayed CMP*

The team injected Quadex I & I Guard®-MSF foam around the pipe, encapsulating the tank, filling voids, stabilizing the soil, and forming a solid watertight barrier. With the ground stabilized, they cleaned the inside of the pipe, repaired a deflected joint, and reshaped the pipe to its original form. Carbon fiber lined any deviations, and they applied 1.5" of GeoKrete® geopolymer, eliminating the corrugations and creating a new, structurally-sound pipe/tank. Vortex managed the entire process, and the only surface disruption was a 3/8" access hole in the parking lot, sealed at project completion.

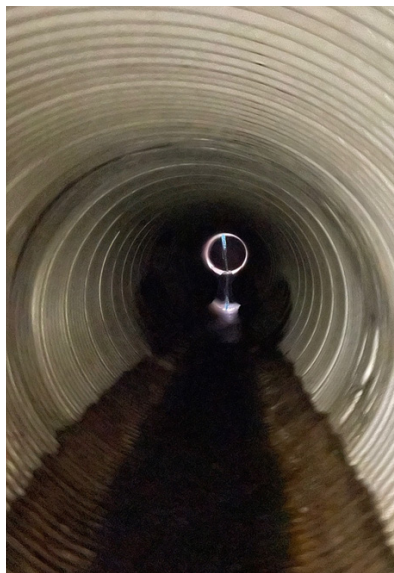
*Pipe deterioration on the invert*

96-inch stormwater corrugated metal pipe (CMP) was deteriorating due to corrosion in the invert of the tank. This corrosion allowed movement that led to failures both at the invert and at joints, permitting soil infiltration into the pipe.

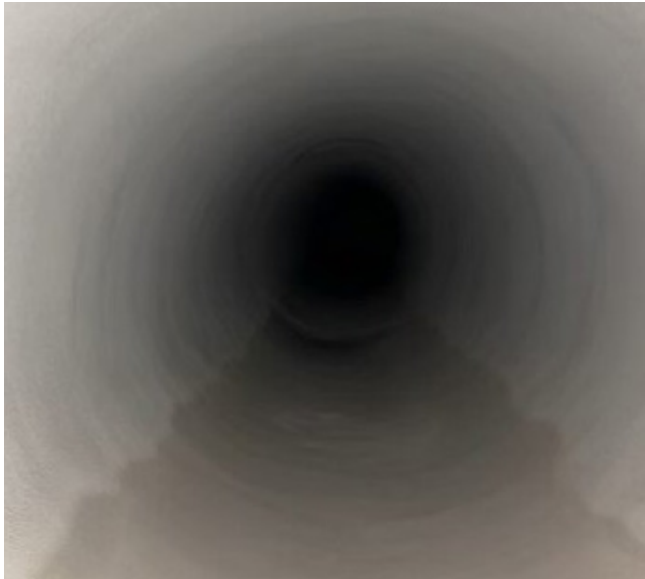
*The rehabilitation eliminated the corrugations and created a new, structurally-sound tank.*
