WASHINGTON NAVY YARD - STEEL LIFT STATION TANK COMPLETELY REHABILITATED USING STRUCTURE GUARD® 100% SOLIDS EPOXY

WASHINGTON NAVY YARD LIFT STATION TANK REHABILITATED WITH STRUCTURE GUARD EPOXY TO ADDRESS CORROSION AND ENVIRONMENTAL CONCERNS

Washington Navy Yard
Steel Lift Station Tank Repair

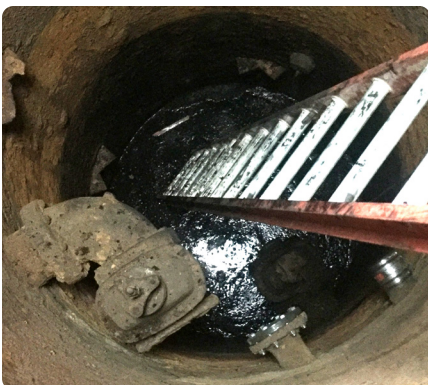
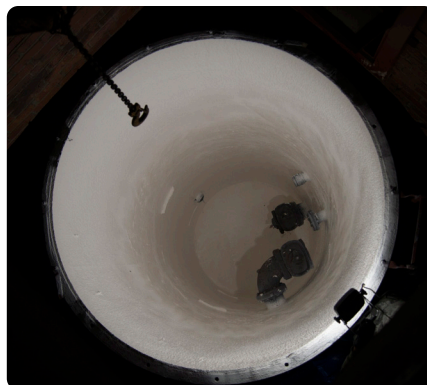
Located along the Anacostia River, parts of the old Navy Yard's sewer infrastructure were in need of repair to avoid leaking and potential contamination. In particular, a steel lift station tank was suffering from severe corrosion and would either need to be completely replaced or rehabilitated.

Suffering from severe corrosion and would have suffered catastrophic failure if not replaced or rehabilitated

Structure Guard® 100% solids epoxy coating to reline and restore

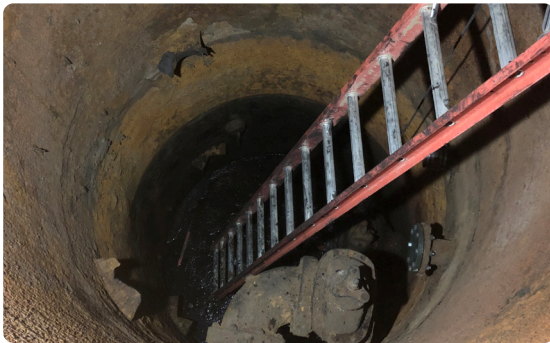
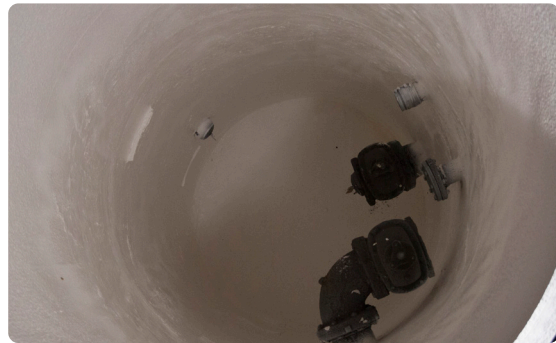
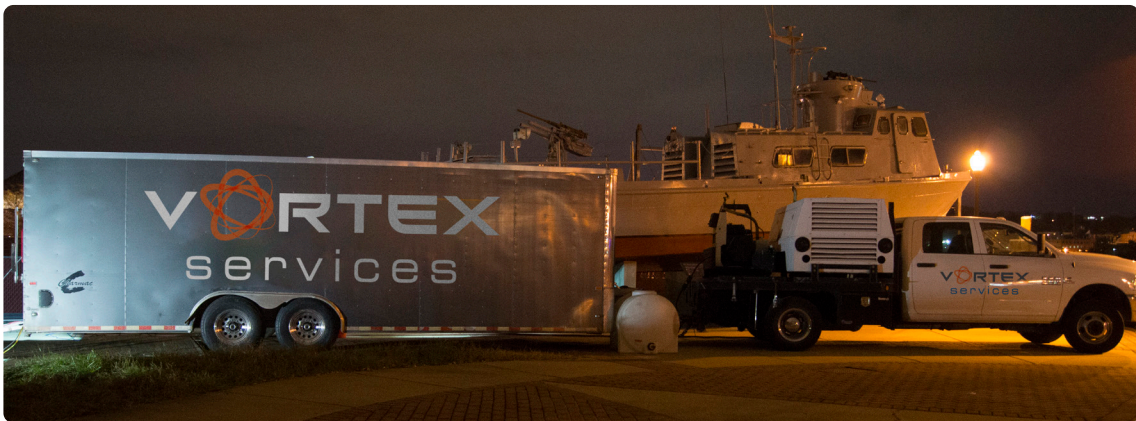
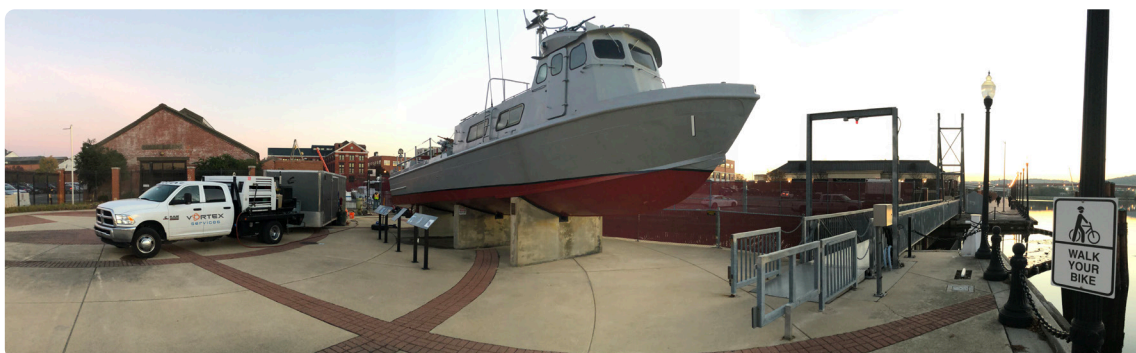
Vortex was able to clean, prep and reline the 60+ year-old lift station tank with Structure Guard Epoxy in two days. Although heavy groundwater infiltration was present, the team was able to work around the problem and complete the installation on time and within budget.
