CASE STUDY

LEAKING OIL/WATER SEPARATORS BROUGHT BACK INTO ENVIRONMENTAL COMPLIANCE

Basins Rehabilitated and Resealed with Quadex® GeoKrete® Geopolymer and Quadex Structure Guard® Epoxy for Private Oil and Gas Company

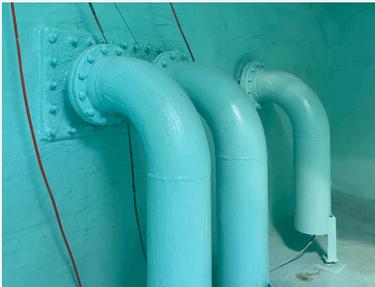
The interiors of Basins 1 and 2 had previously been coated with another manufacturer's epoxy, which was now failing. The project team decided it was best to make use of the remaining portions of the other manufacturer's liner where it remained intact, while preparing the failing sections with a new coating of 100 mil | 2.5mm Quadex® Structure Guard® epoxy. This initial composite liner provided a vapor and moisture barrier within the structure.

Structure Guard® applied to provide vapor and moisture barrier within the structure.

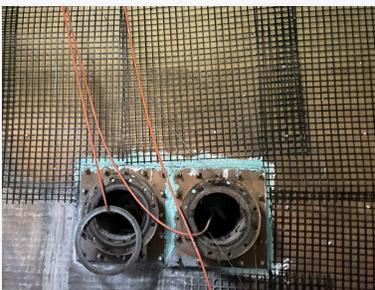
To create an additional barrier to oil seepage and a more predictable surface for further rehabilitation, the crew filled ceiling corrugations and hard corners and applied 1" | 25mm of GeoKrete geopolymer. A C-Grid carbon fiber reinforcement mesh was also anchored within the GeoKrete, further securing it into place. The structure was then top-coated with 250 mil | 6.4mm of Structure Guard epoxy, as a final vapor/moisture and protective barrier. Relying on Vortex's broad lineup of solutions simplified the process, as ancillary products are designed to work with Vortex's primary coating and lining materials. This provides predictability in product interactions, maximizing performance and minimizing compatibility concerns.

Carbon fiber reinforcement mesh was anchored within the GeoKrete® for added strength and stability.

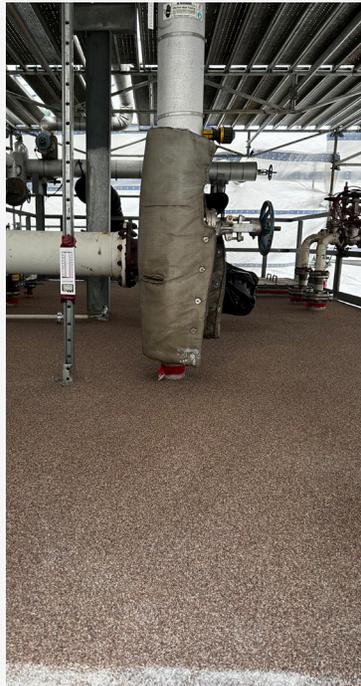
Final patched, repaired top exterior of basin, coated with final application of Quadex E100 Epoxy topcoat and Quadex E240 Epoxy and broadcast quartz applications.

Exterior cleaning revealed oil stains and cracks in the original concrete on top of the structures. The host roof was ground and grouted, and then refinished with a layering of Quadex E240 Epoxy basecoat, hand broadcasted quartz sand aggregate for traction, and a Quadex E100 Epoxy topcoat.

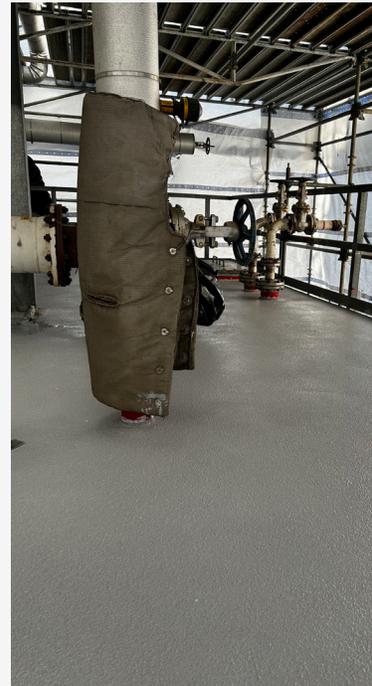
Oil stains and cracks in the original concrete on top of the structures coated with first application of Quadex E240 Epoxy and broadcast with quartz.
