- D-4 Pump Station Stormwater Outfall Rehabilitation

- City of Palm Beach, FL

## PUMP STATION OUTFALL REHABILITATION IN PALM BEACH, FLORIDA PREVENTS FUTURE DAMAGE TO HOME AND ROAD

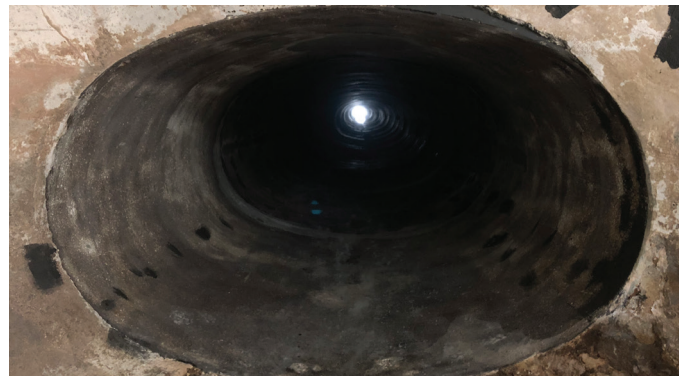
Before

A stormwater outfall serving an exclusive residential community in Palm Beach, Florida had been deteriorating for years. Its proximity to the intracoastal waterway and exposure to a saltwater environment had simply taken their toll. Previous attempts to restore the pipe's integrity had failed and the city was seeking a more permanent structural rehabilitation solution.

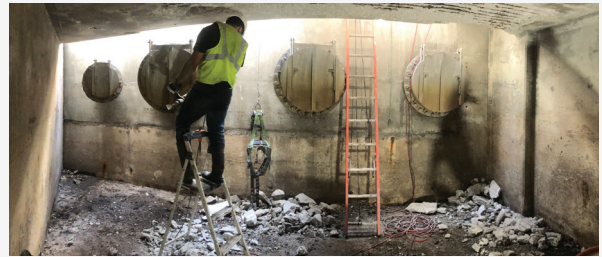
Clear evidence of concrete delamination in the D-4 Pump Station.

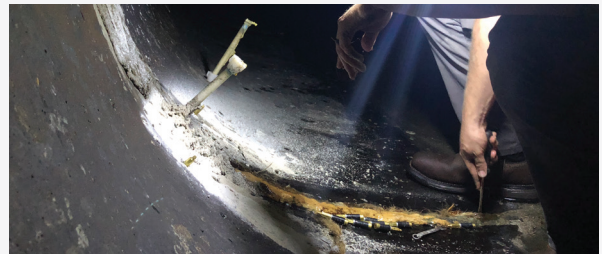
Leaks at the pipe joints were prepped and sealed with I&I Guard-PRF.

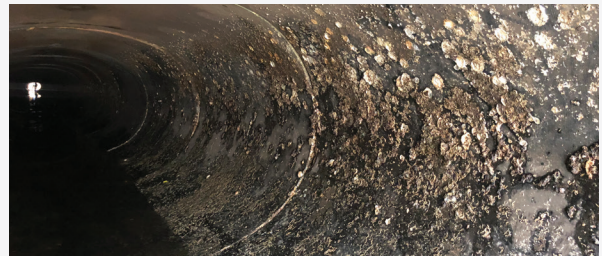
Concrete was deteriorating and joints were leaking.
