Hurricane Harvey Rehab  
Clay Road, Houston, Texas

# GeoKrete® Geopolymer Restores Failing Corrugated Metal Pipes Damaged by Hurricane Harvey, Prevents Potential Collapse

## CMP CULVERTS RUNNING BENEATH BUSY ROADWAY FULLY STRUCTURALLY RESTORED USING COMPLETELY TRENCHLESS GEOPOLYMER SOLUTION

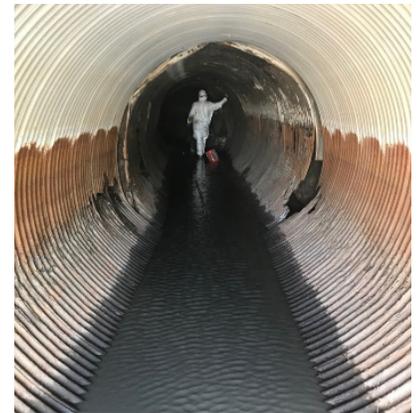
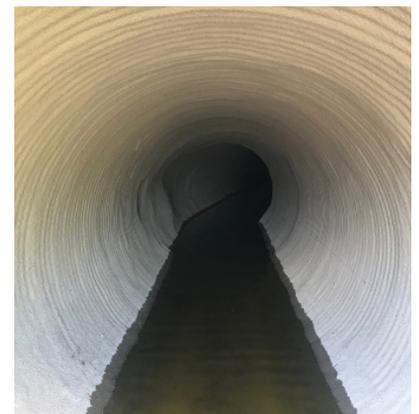
When Harris County Flood Control District officials conducted post-storm inspections, they discovered a three-pipe culvert system beneath a stretch of Clay Road — a highly traveled, multi-lane commuter artery — had begun to fail. Large sections of the CMP (corrugated metal pipes) inverts exhibited corrosion, extreme degradation and wide pipe joint separations, while some sections were missing entirely. The extremely compromised pipes put Clay Road at risk of collapse.

Following standard F1216 practices, the design took all three loads (soil, hydrostatic, traffic) on the roadway into account. Prior to application, accumulated silt and debris were removed and surfaces were cleaned using a 3,500 psi pressure wash. Inverts were sealed with Vortex's Quadex® Quad-Flow, a quick-setting flowable high-strength repair mortar. Standard cementitious material and GeoKrete were used to fill pipe voids. GeoKrete was spray applied into open joints to fill and seal cavities, creating a monolithic structure.
