CASE STUDY

Phoenix Area Stormwater Tank Restoration

TRENCHLESS TANK REHABILITATION OFFERS COST-EFFECTIVE, NON-DISRUPTIVE SOLUTION TO COMMON REGIONAL CHALLENGE.

PROJECT
Chandler, AZ Stormwater Tank

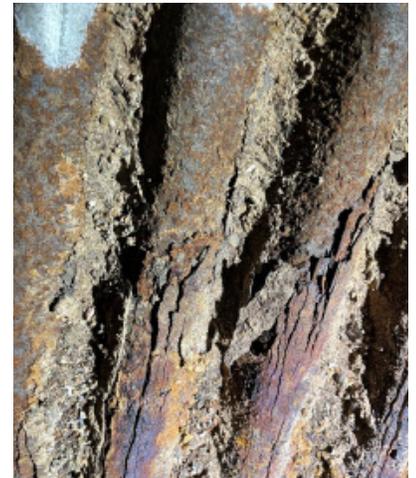
PROBLEM
96-inch stormwater corrugated metal pipe (CMP) was deteriorating due to corrosion in the invert of the tank. This corrosion allowed movement that led to failures both at the invert and at joints, permitting soil infiltration into the pipe. Consequently, soil ingress caused voids to form above and below the pipe, posing a threat of asphalt collapse and potential catastrophic failure.

Closeup of the decayed CMP

The team injected Quadex I & I Guard®-MSF foam around the pipe, encapsulating the tank, filling voids, stabilizing the soil, and forming a solid watertight barrier. With the ground stabilized, they cleaned the inside of the pipe, repaired a deflected joint, and reshaped the pipe to its original form. Carbon fiber lined any deviations, and they applied 1.5" of GeoKrete® geopolymer, eliminating the corrugations and creating a new, structurally-sound pipe/tank. Vortex managed the entire process, and the only surface disruption was a 3/8" access hole in the parking lot, sealed at project completion.

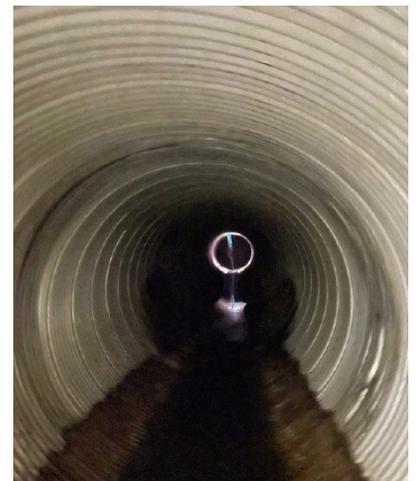
A commercial business used a buried 96" tank made of corrugated metal pipe for stormwater management, but water pooling in the corrugations had rusted the bottom and exfiltrated, leaving voids in the sandy soil beneath. As the tank shifted downward, it created dips in the parking lot above. In extreme cases, similar damage can lead to surface collapse.

Pipe deterioration on the invert
