CASE STUDY

PROJECT
API Basin Rehabilitation

Leaking Oil/Water Separators Brought Back into Environmental Compliance

BASINS REHABILITATED AND RESEALED WITH QUADEX® GEOKRETE® GEOPOLYMER AND QUADEX STRUCTURE GUARD® EPOXY FOR PRIVATE OIL AND GAS COMPANY

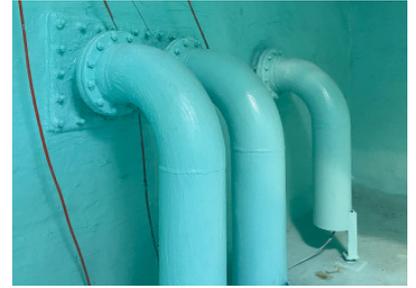
Structure Guard® applied to provide vapor and moisture barrier within the structure.

liner where it remained intact, while preparing the failing sections with a new coating of 100 mil | 2.5mm Quadex® Structure Guard® epoxy. This initial composite liner provided a vapor and moisture barrier within the structure.

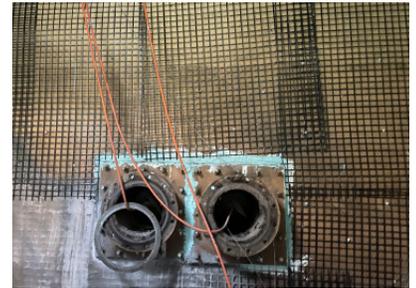
Carbon fiber reinforcement mesh was anchored within the GeoKrete® for added strength and stability.

To create an additional barrier to oil seepage and a more predicable surface for further rehabilitation, the crew filled ceiling corrugations and hard corners and applied 1" | 25mm of GeoKrete geopolymer. A C-Grid carbon fiber reinforcement mesh was also anchored within the GeoKrete®, further securing it into place. The structure was then top-coated with 250 mil | 6.4mm of Structure Guard epoxy, as a final vapor/moisture and protective barrier. Relying on Vortex's broad lineup of solutions simplified the process, as ancillary products are designed to work with Vortex's primary coating and lining materials. This provides predictability in product interactions, maximizing performance and minimizing compatibility concerns.

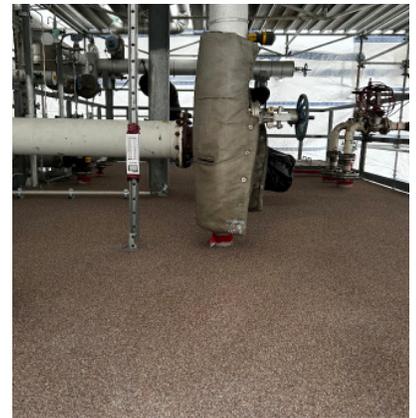
Final patched, repaired top exterior of basin, coated with final application of Quadex E100 Epoxy topcoat and Quadex E240 Epoxy and broadcast quartz applications.

Exterior cleaning revealed oil stains and cracks in the original concrete on top of the structures. The host roof was ground and grouted, and then refinished with a layering of Quadex E240 Epoxy basecoat, hand broadcasted quartz sand aggregate for traction, and a Quadex E100 Epoxy topcoat.

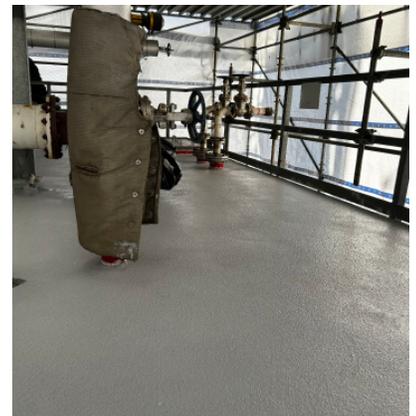
Oil stains and cracks in the original concrete on top of the structures coated with first application of Quadex E240 Epoxy and broadcast with quartz.
