# CASE STUDY

**PROJECT**  
Emergency Manhole Rehabilitation

**OWNER**  
City of Hot Springs Village, AR

### SEVERELY CORRODED MANHOLE REHABILITATED WITH GEOKRETE® GEOPOLYMER SHOW NO SIGNS OF DEGRADATION

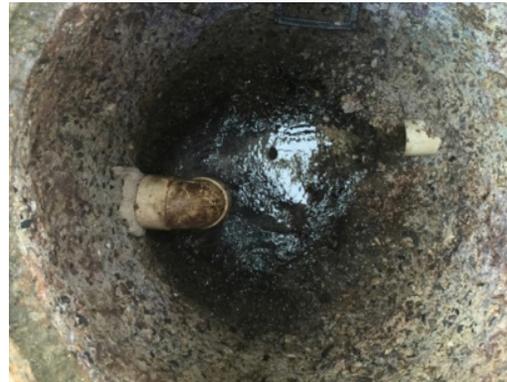
A collection system was experiencing unusually high and consistent levels of H<sub>2</sub>S gas (165-190 ppm). One manhole in particular had completely deteriorated and was originally thought to be beyond repair. The corrosion was so bad, that when the walls were water blasted at 4,000 psi, old concrete and aggregate completely washed away to the soil level in some areas.

2014 — High H<sub>2</sub>S levels caused this manhole to quickly deteriorate to a point where structural integrity and I & I were an issue.

Once the walls were water blasted, the Quadex crew applied Hyperform®, a quick setting patching material, to fill the large voids in preparation for lining.

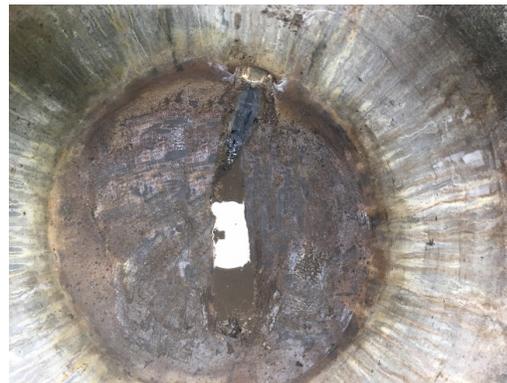
2018 — Approximately four years later the GeoKrete lined manhole shows no signs of degradation.

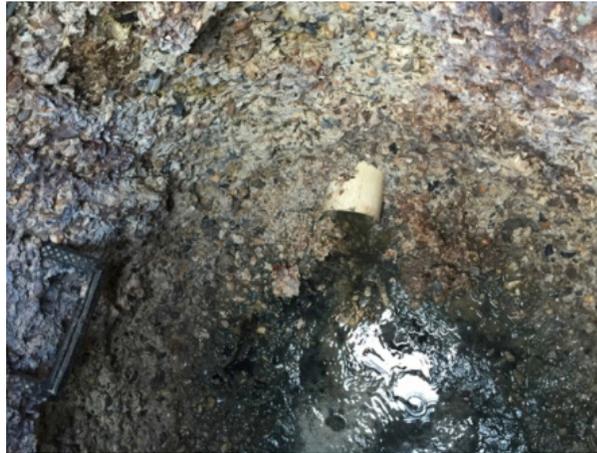
*The corrosion was so bad, the manhole needed to be completely reprofiled.*

A Certified Quadex Applicator spray-applied the GeoKrete to a 1.5" thickness. A trowel was then used to create a smooth finish.

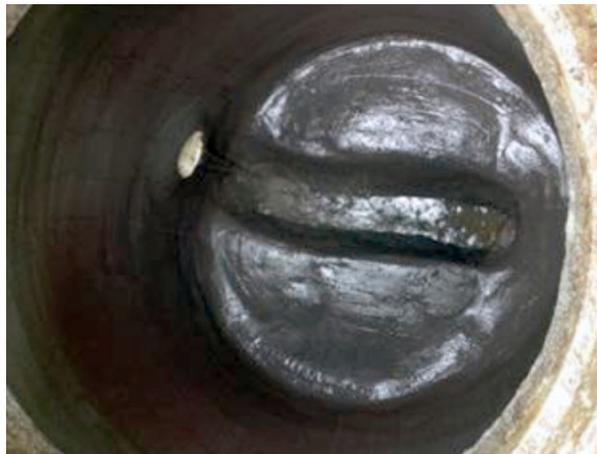
*2014 — This photo shows the manhole just after it was lined with Geokrete. Note the smooth finish and rebuilt flow channel at the bottom.*

A new flow channel also had to be constructed at the manhole's base. The original was so deteriorated and started to dissolve during the water blasting procedure.
