CASE STUDY

Collapsed and Corroded Culvert Structurally Relined, Avoiding the Need for Intrusive Excavation

PROTOTYPE APPLICATION OF THE QUADEX LINING SYSTEM® FEATURING GEOKRETE® GEOPOLYMER

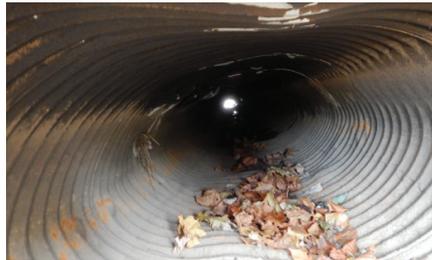
July 2015
Pipe sections showed signs of partial collapse.

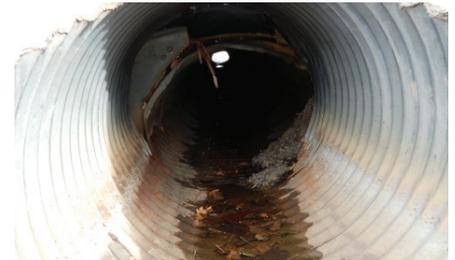
October 2017
Section of pipe where partial collapse existed remains in excellent shape after it was structurally relined with GeoKrete.

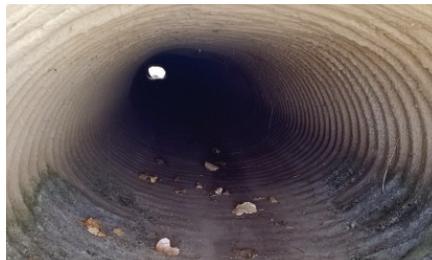
July 2015
Complete joint failure with pipe suffering from severe ovality, I & I and threat of total collapse.

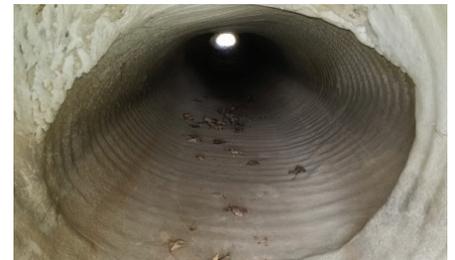
October 2017
No signs of joint failure or ovality as depicted in the host pipe. Structural GeoKrete liner is intact and continues to provide corrosion protection.
