New Hampshire DOT – Culvert Slipline Rehabilitation NH-114 Over Bowman Brook

# Structural Rehabilitation of Corrugated Metal Storm Pipe Using QLS Spin-Cast GeoKrete Pipe Lining System

## NEW HAMPSHIRE DOT STORM PIPE REHABILITATION USING GEOPOLYMER LINING SYSTEM

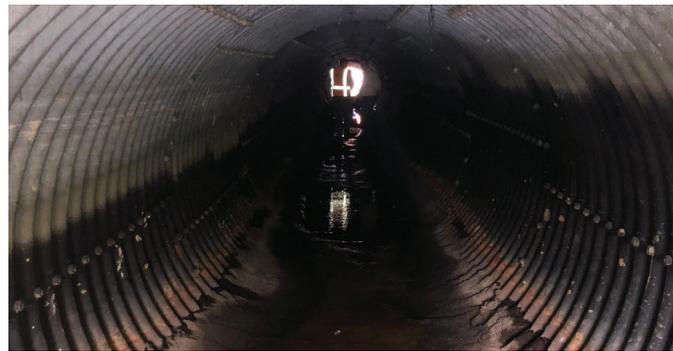
A CMP storm culvert, installed by the New Hampshire DOT decades ago, had seen better days. Due to its age, the structural integrity of a 210 LF of 90" corrugated metal storm pipe had been compromised. There was so much corrosion, the invert had completely degraded and was missing; causing the culvert pipe to depress and take on more of an elliptical shape from the original 90" round shape. Complicating the issue was the discovery of missing pipe sections... again due to years of use and corrosion build-up over time. Left unrepaired, the roadway above would begin to sink and potentially lead to a collapse of the pipe and roadway.

*Compromised 90" corrugated metal pipe*

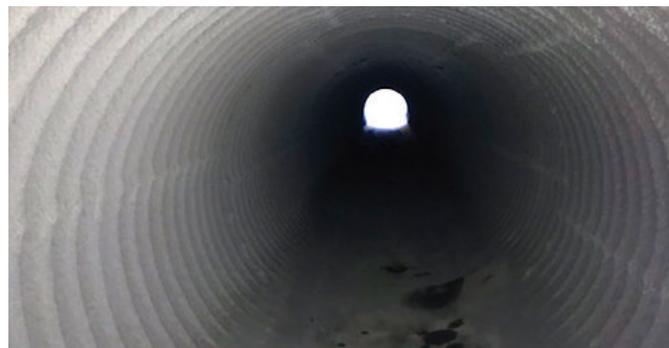
*CMP restored using the Quadex Lining System® (QLS)*

Given the full structural restoration capability of the geopolymer lining process, along with its ability to work in confined areas; the general contractor selected the Quadex Lining System® (QLS). Critical to this selection was that QLS materials, equipment and personnel deliver a completely turnkey solution from a single source supplier. QLS crews are highly experienced in working with the material and operating the machinery. Since it all comes from the same company, typical issues between the product manufacturer and the contractor do not exist, as they are one in the same. In addition to this advantage, Quadex staff engineers and technical support help ensure a quality and consistent application from initial design to completion.

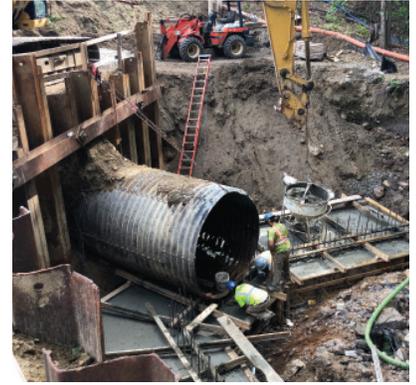
*NHDOT culvert required significant reinforcement as part of the entire rehab process.*

On this project, a bypass system was required to divert the brook and stormwater flow. Once operational, the culvert was cleaned, debris was removed and extensive invert repairs were made. In addition, the portions of missing pipe (at 3 o'clock and 9 o'clock) were also repaired. Typically a reinforcing mesh or grate, combined with hand-troweled GeoKrete®, fill these voids prior to the pipe relining. Once done, GeoKrete was precision spin-cast to a 2" thickness design. The completed project met all objectives and requirements set prior to repair and was the first approved and completed GeoKrete geopolymer lining installation with the New Hampshire Department of Transportation.

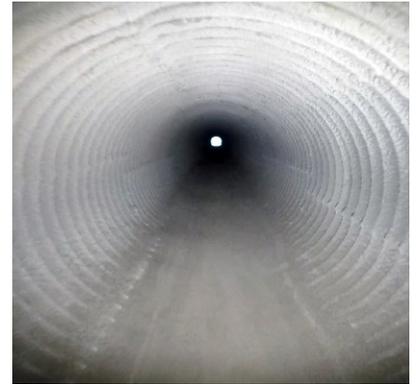
*Post installation inspection of the GeoKrete lined culvert shows precision and cleanliness of the application.*

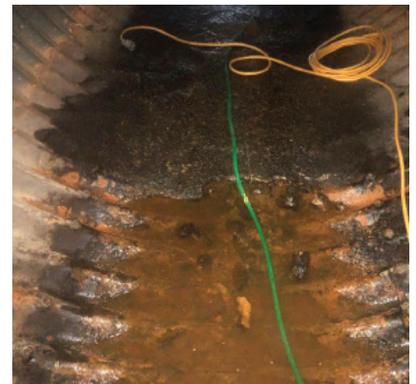
*Previous attempts to reline the corroded invert had failed.*
