Guernsey County, OH  
Culvert Rehabilitation

# ODOT: 50+ Year-Old Culvert in Remote Location Structurally Restored with GeoKrete® Geopolymer

Loveland, Ohio 78" Culvert Rehabilitation

# Failing 62-Year-Old Corrugated Metal Pipe Gets New Life

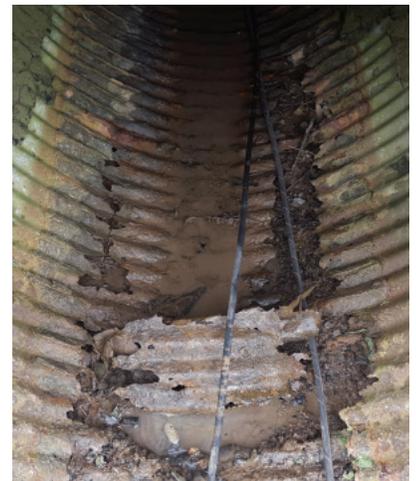
Culvert installed in 1963. Invert was completely deteriorated and there was extensive corrosion on the inner pipe wall.

A 50+ year old CMP storm culvert pipe in Guernsey County, OH was found to be in very bad condition. The invert was nearly gone and corrosion inside the pipe threatened a complete failure in the near future.

*This old CMP culvert was completely corroded through in many areas.*

Once in place, the old culvert was cleaned, prepped and patched before the relining process started. In addition to rebuilding the invert, the QLS crew relined the 54" CMP pipe over period of three days. A total of two passes were made by QLS's advanced application sled, to achieve a thickness of 1.5".

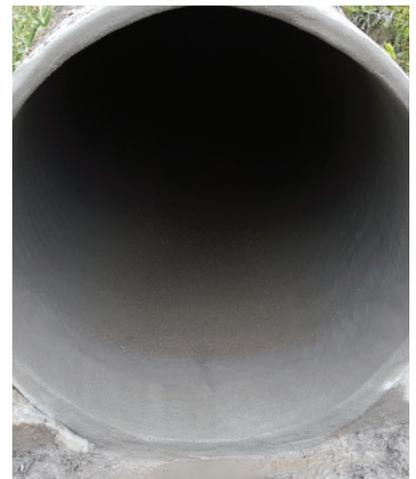
*QLS GeoKrete® was spin-cast for a smooth, structural and corrosion resistant finish.*

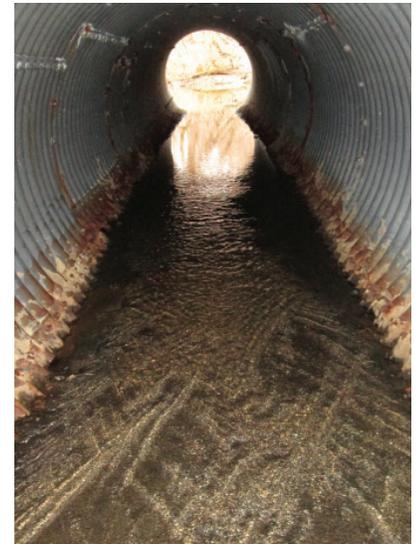
Culvert installed in 1954. Invert was in poor condition and existence of corrosion on pipe's inner walls. Running beneath a roadway, a full structural renewal was required.

A 78" CMP storm drain running beneath a road in Loveland, Ohio had begun to fail. With the invert in need of repair and corrosion eating at the inside, complete failure was imminent. The 62 year-old pipe had exceeded its design life and needed to be structurally restored, or ultimately it would need to be replaced.

78" CMP was corroded and failing.

RB Jergens, the prime contractor, recommended the Quadex Lining System® (QLS) as an alternative to replacement. The system features GeoKrete® Geopolymer and possesses both excellent corrosion resistance and structural properties. In this case, GeoKrete® was spray-applied to achieve a thickness of 2" to protect and restore the culvert to its original integrity. The roadway above was never closed, however a temporary traffic signal (to control traffic flow) was installed in conjunction with the lining work to ensure proper safety for all crews involved.

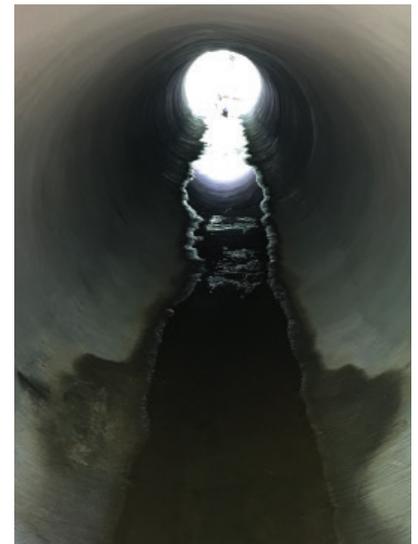
QLS GeoKrete® was spray-applied, then troweled to achieve a smooth consistent thickness.

QLS process, spray-applied GeoKrete® to achieve 2" thickness. Smooth finished with trowel.
