D-4 Pump Station Stormwater Outfall Rehabilitation

A Failing, 350 LF Stormwater Outfall, in an Exclusive Palm Beach, FL Residential Community, is Fully Rehabilitated to Avoid Imminent Damage and Potential Sinkage of Nearby Home

PUMP STATION OUTFALL REHABILITATION IN PALM BEACH, FLORIDA PREVENTS FUTURE DAMAGE TO HOME AND ROAD

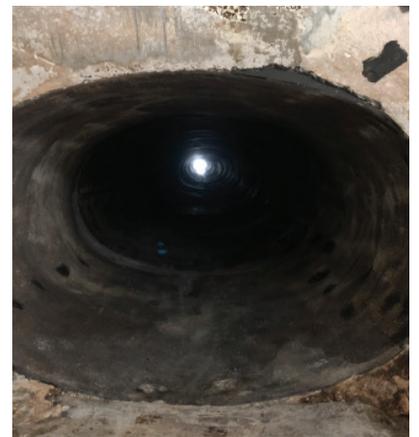
Before

A stormwater outfall serving an exclusive residential community in Palm Beach, Florida had been deteriorating for years. Its proximity to the intracoastal waterway and exposure to a saltwater environment had simply taken their toll. Previous attempts to restore the pipe's integrity had failed and the city was seeking a more permanent structural rehabilitation solution.

Without a quick repair, there were legitimate concerns about the outfall's structural integrity due to its continued degradation. If the pipe collapsed, sink holes could have formed and a nearby home and road above would have suffered severe damage as a result.

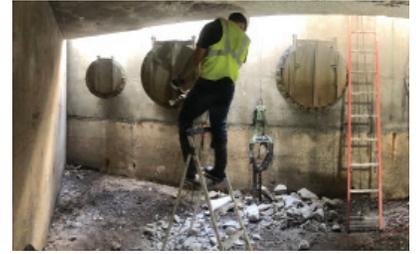
Clear evidence of concrete delamination in the D-4 Pump Station.

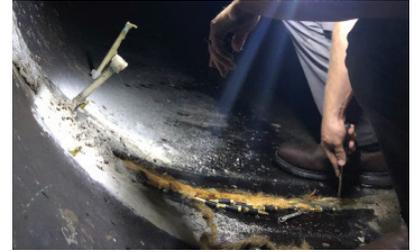
Leaks at the pipe joints were prepped and sealed with I & I Guard-PRF.

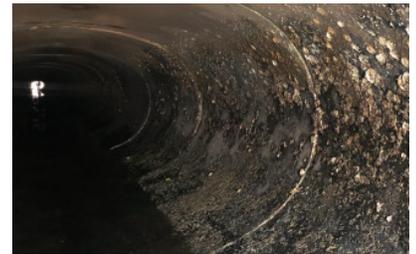
Concrete was deteriorating and joints were leaking.

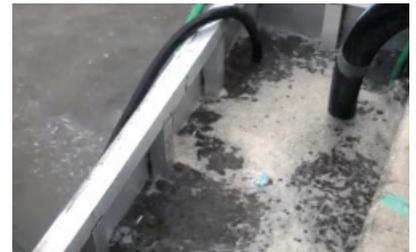
Daily dewatering was necessary due to outfall's proximity to the intracoastal waterway.

The exceptionally high rate of dewatering required an innovative solution to the bypass. Because of normal tidal flow, the outfall was completely submerged under water a significant portion of the day. In order to dewater the tunnel, the Vortex Services crew designed a steel box that was bolted to the pipe wall to attach the bypass pumps. Due to the consistently high water level, this had to be performed by a dive team.
