CASE STUDY

Washington Navy Yard – Steel Lift Station Tank Repair

Washington Navy Yard Lift Station Tank Rehabilitated with Structure Guard Epoxy to Address Corrosion and Environmental Concerns

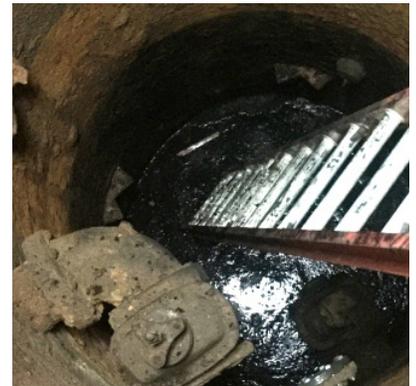
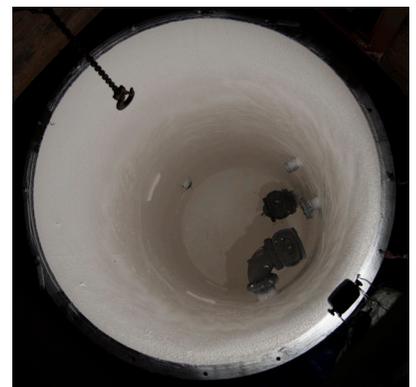
Suffering from severe corrosion and would have suffered catastrophic failure if not replaced or rehabilitated

In particular, a steel lift station tank was suffering from severe corrosion and would either need to be completely replaced or rehabilitated.
