**CASE
STUDY**

PROJECT OWNER
Genessee County

CONTRACTOR
Vortex Lining Services

Dam Spillway Rehabilitation in Genessee County, MI

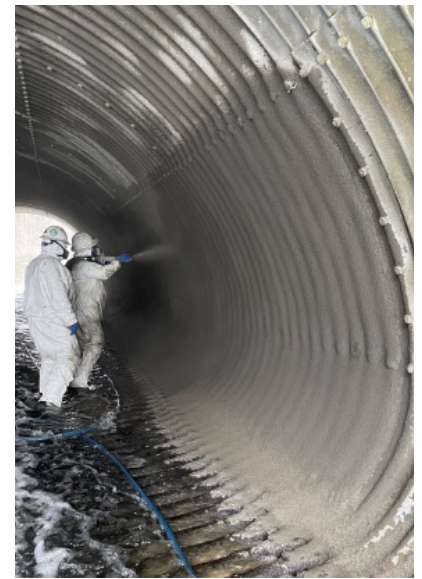
In early 2022, Genessee County, Michigan discovered that one of its spillway pipes was in need of serious repair. The county's Atlas Dam Spillway is next to a large lake that stores runoff captured from a nearby township. It carries all overflow to the river on the other side of the Atlas Dam. This 204" x 134" corrugated metal spillway was experiencing groundwater infiltration via leaks in the piping. Genessee County reached out to Vortex Lining Services (VLS) about rehabilitating the asset based on the VLS team's high level of experience. Together, Genessee County and the VLS squad created a plan and proposal to fit the county's rehabilitation needs.
