## CASE STUDY

## AEP NIAGARA HYDRO ELECTRIC PLANT 78" AND 66" STEEL PENSTOCKS

- Penstock Restoration

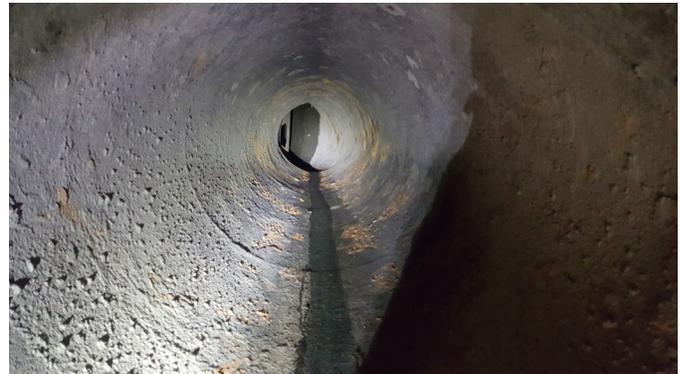
External view of 45° angled penstocks.

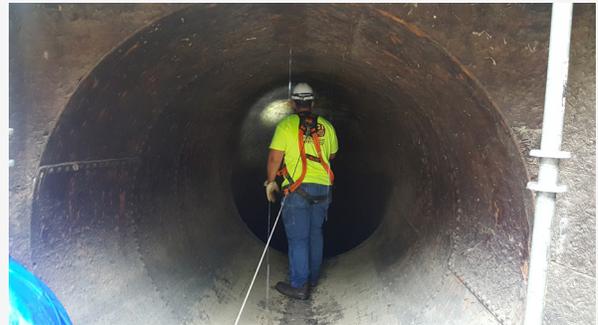
*Peering down the steep slope of penstock.*

In closing, although AEP initially selected QLS for GeoKrete's performance properties, the QLS crew's strong safety score was also a factor. This installation proved to be a challenge due to the extreme slope grade. Safety, awareness and special attention to harnessing was paramount.

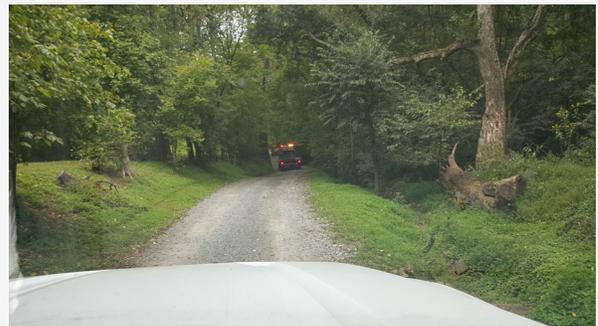
*Remote access and narrow pathways.*

The CIPP process was considered but the combination of limited access and steep grades would have made it very expensive and too risky. The pipe entry was down an embankment that didn't allow vehicles, not to mention the site's access was extremely limited and would have required a helicopter to get CIPP liner into place.

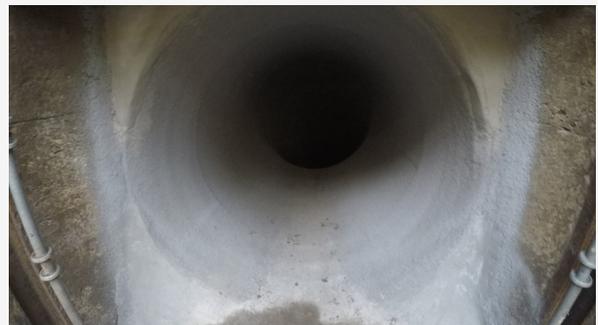
*GeoKrete Liner - Structural renewal & restored flow capacity.*

What makes QLS truly unique is the GeoKrete® Geopolymer applied to the structures. Developed by Quadex LLC, it is a fully structural, corrosion resistant material that will not crack, peel or degrade over time.
