### 50 YEAR-OLD, DETERIORATED STEAM TUNNEL ON UNIVERSITY OF PITTSBURGH CAMPUS STRUCTURALLY REHABILITATED WITH GEOKRETE® GEOPOLYMER

**CORRODED STEEL PLATE TUNNEL, BURIED IN FRONT OF THE CATHEDRAL OF LEARNING, STRUCTURALLY RESTORED VIA INNOVATIVE TRENCHLESS SOLUTION**

University of Pittsburgh - 5th Avenue  
Steam Tunnel Rehabilitation  
(Pittsburgh, PA)

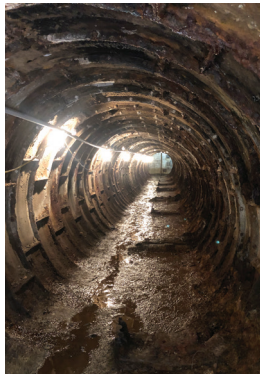
*Condition of steam tunnel proper to QLS/GeoKrete® installation.*

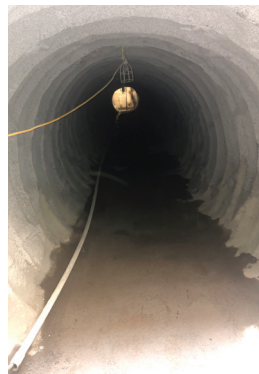
*After the steam tunnel is lined with GeoKrete and floor leveled with Quad-Flow.*

Prior to the lining process, all piping and brackets needed to be removed. It was also determined that the invert of the pipe needed to be raised 1.5" and then leveled to a flat surface bottom to make is safer for maintenance crews to walk through the tunnel in the future.

To achieve this, Vortex engineers recommended Quadex Quad- Flow for its high-build, self leveling properties. Once the floor was cured, the piping and bracket supports were installed. The crew then lined around these supports, while a second crew followed with bracket and piping installation.

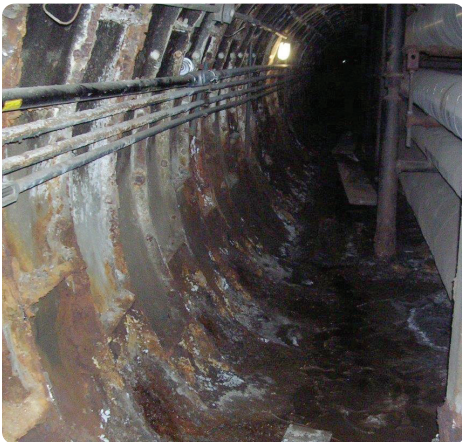
*Condition of the tunnel and placement of the conduit prior to removal and rehabilitation.*

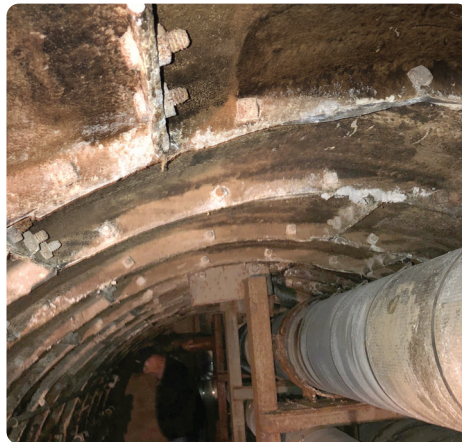
*Severe corrosion threatened the structural integrity of the old steam pipe.*

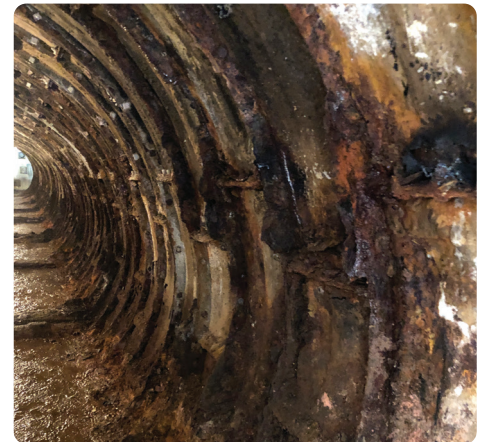
*The old piping and conduit was removed prior to relining the tunnel with QLS/GeoKrete.*

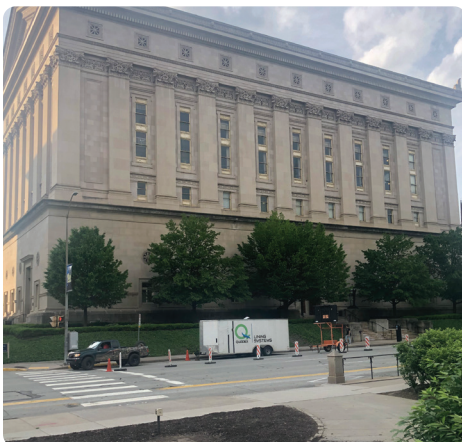
*Note the small construction footprint of the QLS system.*

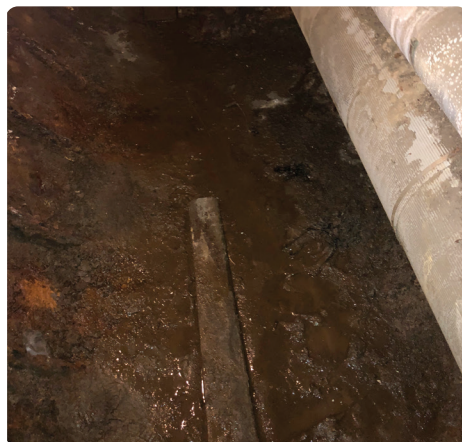
*The original rounded floor of the steam tunnel was not only slippery, it was difficult for maintenance crews to gain purchase.*

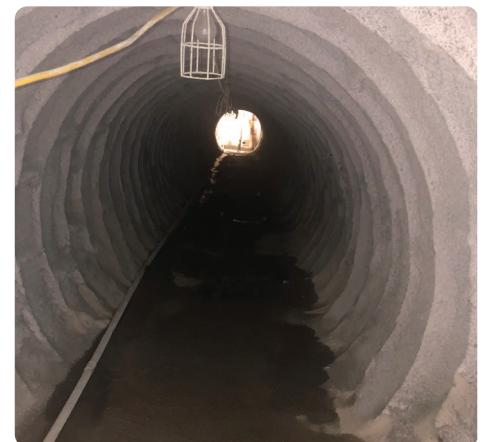
*After 1.5" of QLS GeoKrete was spray-applied to structurally renew the deteriorating steam tunnel.*
