Vortex I & I Guard®-SSF Stops Soil Erosion and Preserves Seawall

FLORIDA-BASED ENGINEERING SERVICES COMPANY, SPECIALIZING IN GEOTECHNICAL SOLUTIONS SAVES OCEAN-FRONT CUSTOMERS CONDO OWNERS AN AVERAGE OF \$35,000-\$40,000. SOIL STABILIZATION FOAM PROVES TO BE EXCELLENT EROSION AND PERMANENT SHORING SOLUTION FOR COASTAL COMMUNITIES.

Tampa Area Condominiums & Townhomes

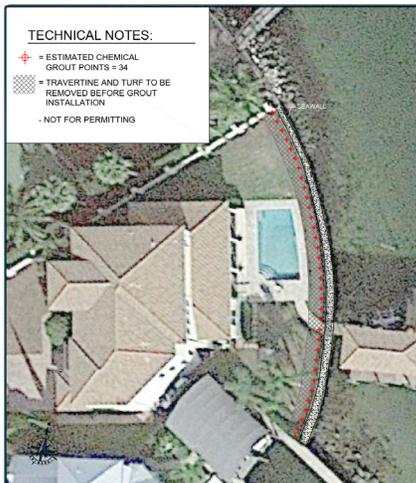
Injection port, to install I & I Guard-SSF, identified along condo property seawall, will fill voids caused by erosion and prevent seawall from collapse.

The chemical grout was not only used to fill depressions and voids, but also to compact the ground – an important step that creates a protective barrier behind the seawall to prevent soil migration into the ocean.

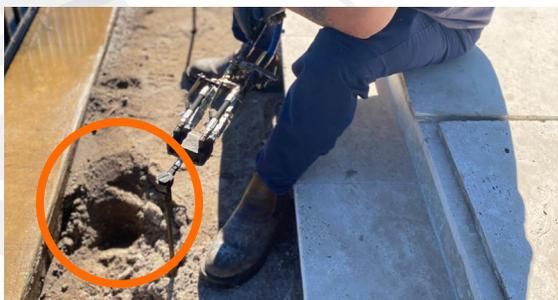
As technician injects I&I Guard - SSF into void behind seawall, signs of soil erosion were evident.

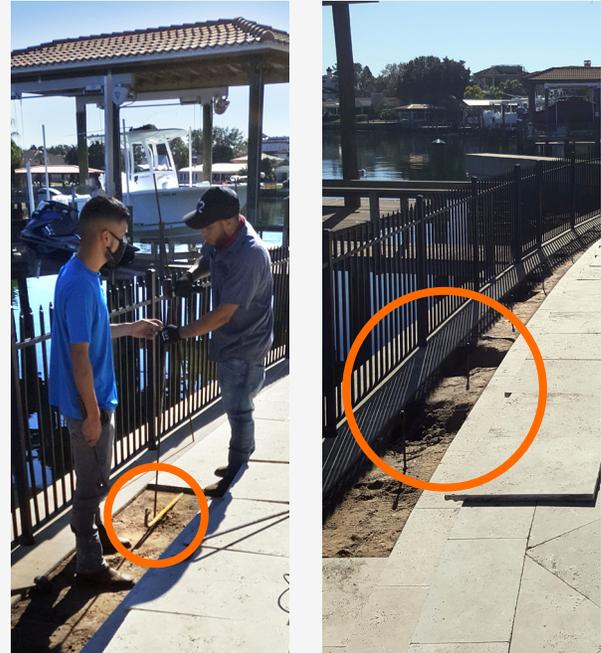
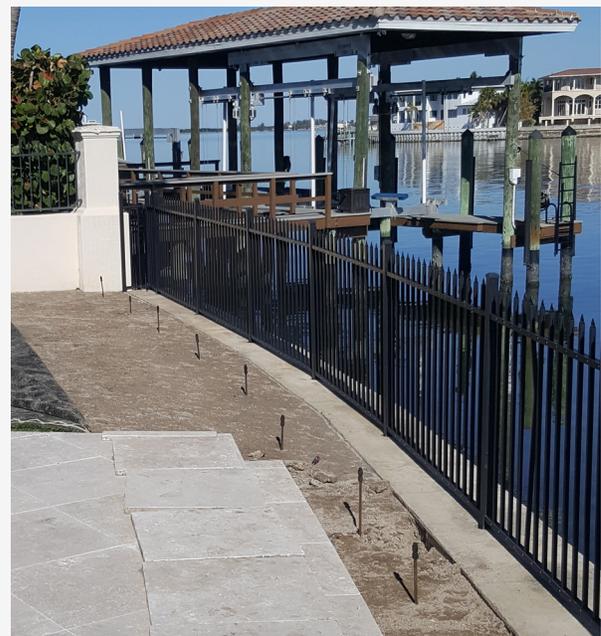
Pilot holes are drilled along top and sides of seawall, where I & I Guard-SSF will be applied. No digging or replacement of backfill of seawall was required.
