CASE STUDY

Multiple Trenchless Technologies Used to Rehabilitate Aging Infrastructure on Liberty Island, Home of the Statue of Liberty

UV CIPP LINER AND GEOKRETE® GEOPOLYMER MORTAR STRUCTURALLY RESTORES MANHOLES AND RELINES AGING SEWER LINER WITHOUT THE NEED FOR DIGGING

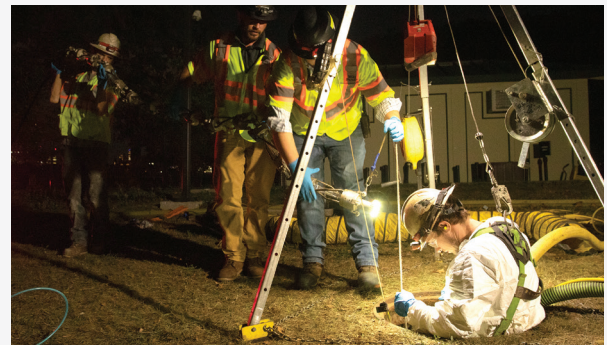
Vortex Services installation crew inserting the UV light chain into the manhole to begin the UV curing process.

The process included jet cleaning and prepping the sewer line and manholes for rehabilitation. For the manholes, GeoKrete® geopolymer was spray-applied to approximately 1" thick, troweled, and brushed to a smooth finish to restore full structural integrity. The sewer pipe was relined using the UV CIPP process, which was recommended for its environmentally friendly design and quick cure ability given the limited time the crew had to install each night.

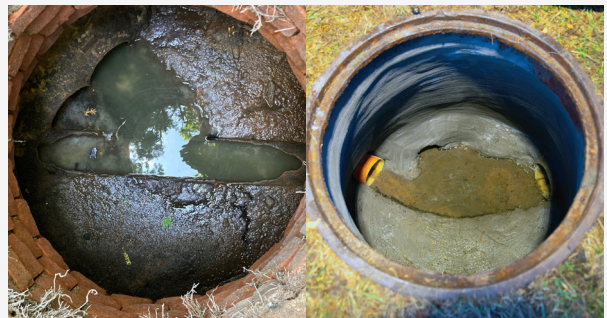
Manholes were deteriorated and leaking.

GeoKrete geopolymer was applied to structurally reinforce the manhole.

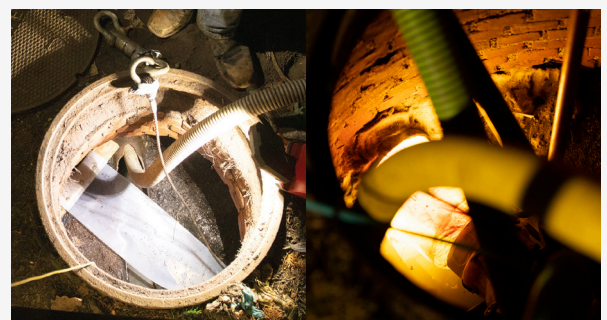
A glider foil, installed prior to inserting the UV liner, reduces friction during liner pull-in process.

Liner being cured with UV light chain.
