## CASE STUDY

Structure Guard®  
Installation Eliminates  
Costly & Extended  
Bypass Pumping in  
Two Days, Saving a  
Minimum of \$35,000

Central Valley Water Reclamation Facility

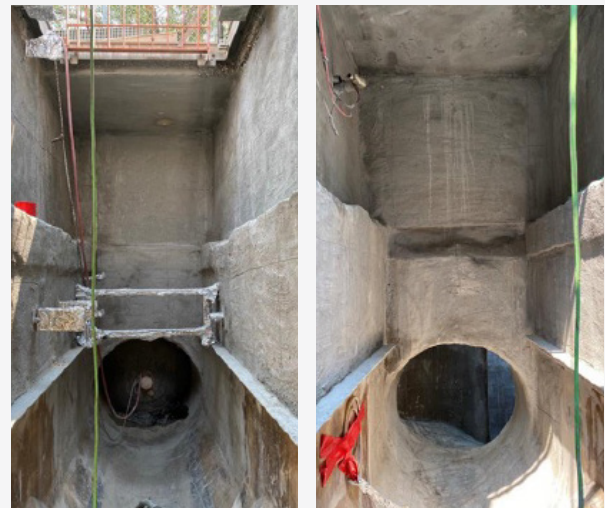
CVWRF's massive plant expansion required the rehabilitation of several thousand feet of large diameter interceptor pipelines, which dropped down into a stipend before extending under the river. Years of adverse conditions, such as high levels of CO<sub>2</sub>, H<sub>2</sub>S and NH<sub>3</sub> gases and humidity led to the structure's deterioration. Additionally, since it was so close to the river, the only option for repair was trenchless rehabilitation. CVWRF's subcontractor set up a bypass, which was planned to be in place for only two weeks to allow for necessary repairs. However, the bypass was in place for nearly three months – and on pump watch 24/7 at a cost of approximately \$5,000 per day – due to the subcontractor using a urethane coating that didn't suit the needs of the environment and a general misunderstanding of the structure's condition and repair needs.

*Years of exposure left the interceptor pipeline and siphons in a highly deteriorated condition.*

Within two days, Vortex (in partnership with its certified installation partner Cardinal Coatings) applied Structure Guard®, a 100% solids epoxy coating to provide long-term corrosion protection and structural enhancement. Structure Guard's hydrophobic properties and impermeability to hydrogen sulfide gas also enable it to thrive in moist environments, while ensuring a safe, tenacious bond to whichever substrate it's applied. In contrast, when urethanes are applied in damp conditions, they create a microbubble layer which causes interface and delamination issues that can produce toxic hydrogen sulfide gas and deposit gypsum into the wastewater treatment process.

As a result of applying Structure Guard to the metering vault and inlet siphons, the bypass – which had been in place nearly three months – was dismantled after two days.
