CASE STUDY

STORMWATER REHABILITATION IN THE CITY OF BEAUMONT, TEXAS

City searching for stormwater drain rehabilitation solutions.

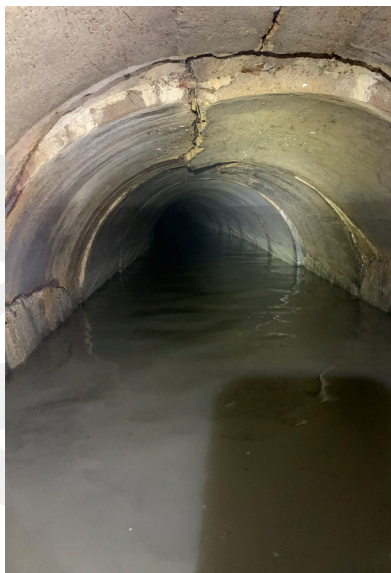
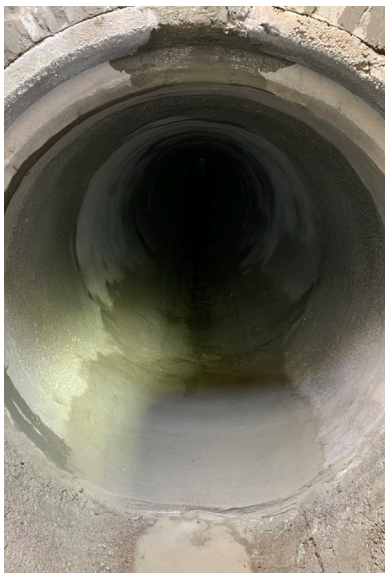
To kick off the job, the VLS crew began work by putting a bypass system in place. Once it was operational, the team cleaned the 3,128 LF stormwater drain section and performed a point repair on the collapsed area (174 LF).

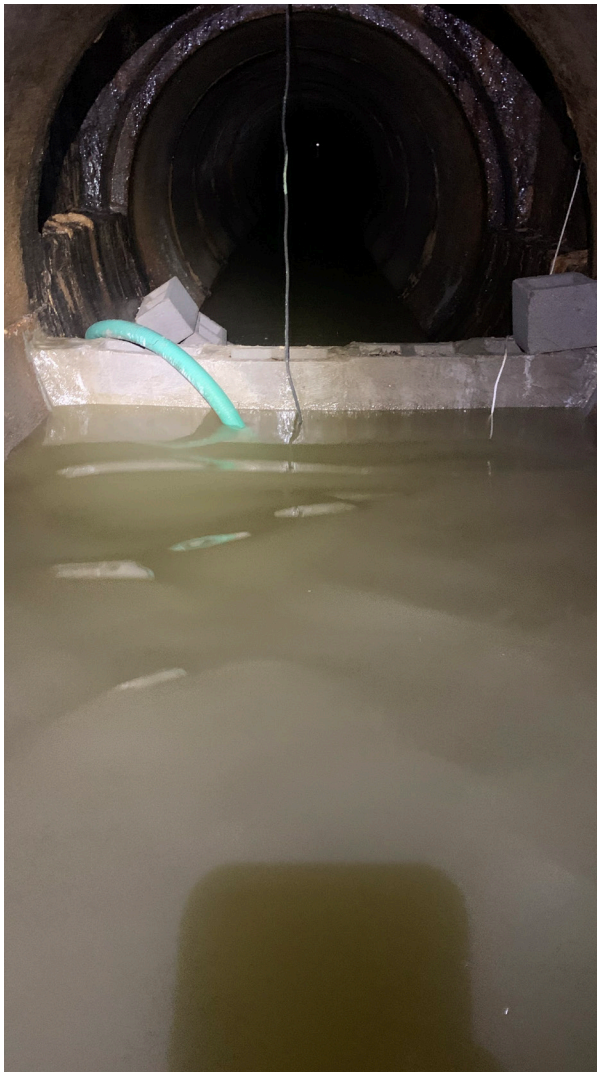
Next, the crew spray-applied the piping using Quadex® GeoKrete® structural geopolymer, which structurally restored the asset, returning it to its full strength and capacity. The team went on to line another 6,528 VF of manhole structures with GeoKrete. Next, the squad utilized ground penetrating radar (GPR) equipment to locate voids along this run of piping. They then used a combination of Quad-Plug® leak stoppage material and Hyperform® rapid-set patching material to further secure the drain and restore the pipe's invert. The crew finished work by injecting I&I Guard®-MSF (Soil Stabilization Foam) polyurethane resin to stabilize the surrounding soil and completely fill any remaining voids.
