## CASE STUDY

# DAM SPILLWAY REHABILITATION IN GENESSEE COUNTY, MI

County searching for spillway rehabilitation solution.

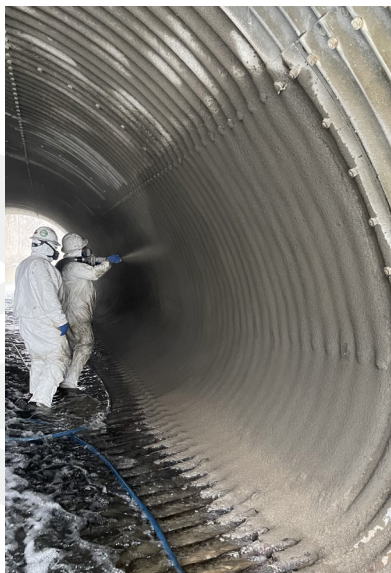
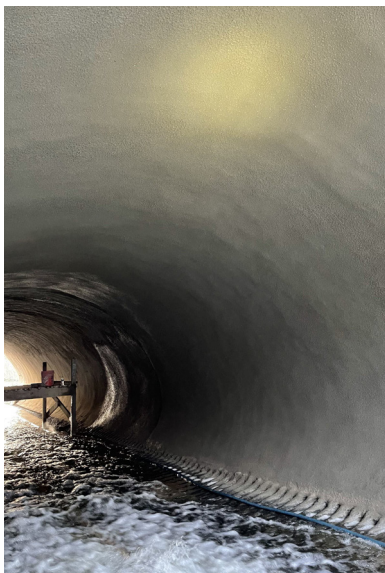
In early 2022, Genessee County, Michigan discovered that one of its spillway pipes was in need of serious repair. The county's Atlas Dam Spillway is next to a large lake that stores runoff captured from a nearby township. It carries all overflow to the river on the other side of the Atlas Dam. This 204" x 134" corrugated metal spillway was experiencing groundwater infiltration via leaks in the piping. Genessee County reached out to Vortex Lining Services (VLS) about rehabilitating the asset based on the VLS team's high level of experience. Together, Genessee County and the VLS squad created a plan and proposal to fit the county's rehabilitation needs.

Genessee County's 204" x 134" corrugated metal dam spillway pipe was deteriorating and suffering from ground infiltration.

Once the setting up and staging of the jobsite was complete, the VLS crew got to work in earnest. In mid-April, they began the rehabilitation stage of the job, which necessitated difficult flow diversion measures. The bypass was very tricky, as heavy rain caused all the runoff to move into the reservoir above the spillway. This meant that the team could not control the lake's water level as much as they wanted to. To mitigate the flow of water, the

The VLS team spin-cast a 4" thick lining of Quadex® GeoKrete® structural geopolymer onto the spillway piping and applied an additional 1" of GeoKrete geopolymer with #57 stone aggregate embedded to the floor of the pipe.
