CASE STUDY

MANHOLE REPAIR IN VICTORIA, BC

City looking for manhole rehabilitation solutions.

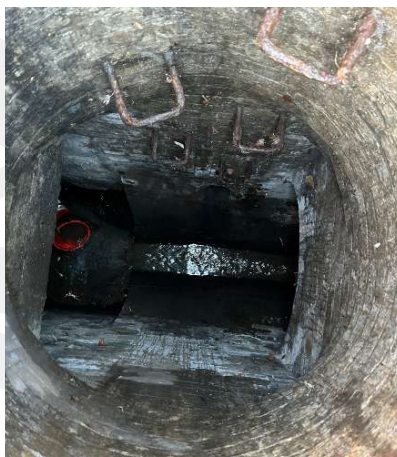
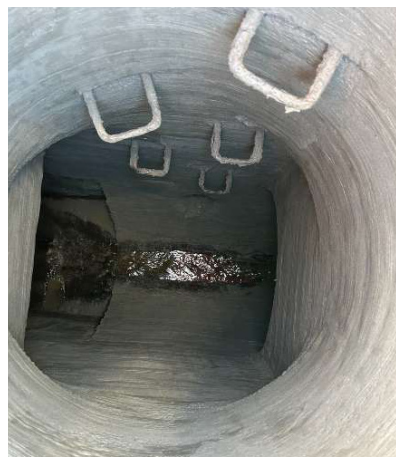
After cleaning the manholes, the team applied Quadex® Quad-Plug® to repair and restore broken or missing sections of the trough and bench. Hyperform®, rapid-set patching material was then used to fill shape the bench and fill voids in the chimney.

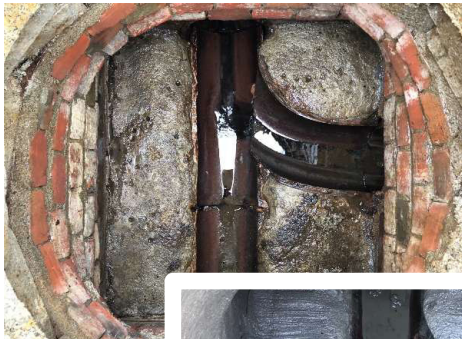
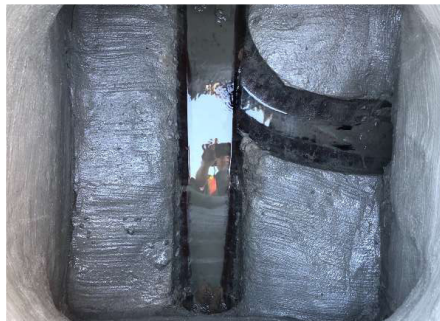
Finally the team spin-cast and spray-applied approximately 1 in. of Quadex® GeoKrete structural geopolymer mortar onto each one to restore their structural integrity. Once troweled to a smooth finish, the manholes were ready for service in less than 24 hours.
