CASE STUDY

COMBINING STRUCTURAL PROPERTIES OF ALUMINALINER® WITH CORROSION PREVENTION OF STRUCTURE GUARD® FOR ULTIMATE MANHOLE REHABILITATION SOLUTION

Successful Pilot Project in Denver, CO Convinces Asset Owner that Rehab Solution Delivers Better Performance and Cost Savings Over Traditional Dig and Replace.

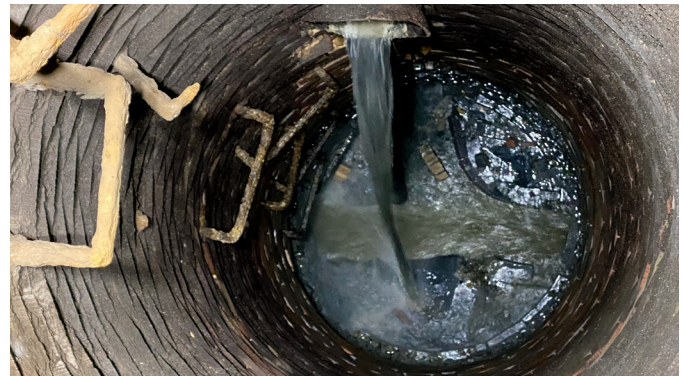
Deteriorating and exposed brick manhole with actively flowing service line.

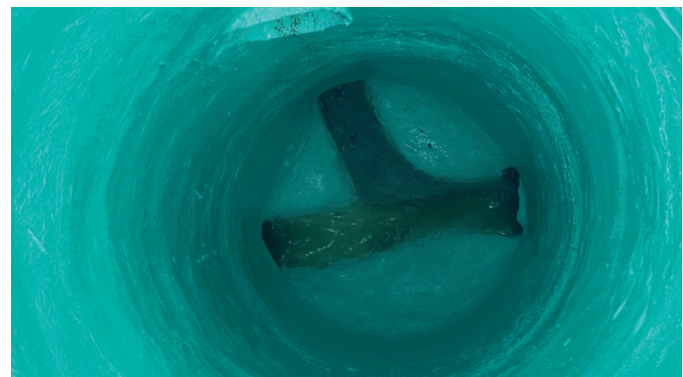
Rehabilitated manhole after being lined with underlayment of AluminaLiner and topcoated with Structure Guard.

After cleaning and preparing the manhole surface, the contractor needed to address the constant flow coming from the 10-inch mid-drop service line. By installing a flow-thru plug, the contractor avoided the cost of a complete bypass, to allow the entire structure to be completely lined and coated. For full structural support, a 1-inch layer Aluminaliner, a factory blended, single component, fiber reinforced, 100% calcium aluminate cement was first applied as an underlayment, then allowed to cure for 24 hours. The following day, Structure Guard, a 100% solids epoxy was spray applied at 125 mils. Aluminaliner provides both structural integrity and corrosion resistance while stopping groundwater infiltration. Structure Guard provides extreme corrosion protection and exceptional abrasion resistance for long-term protection.

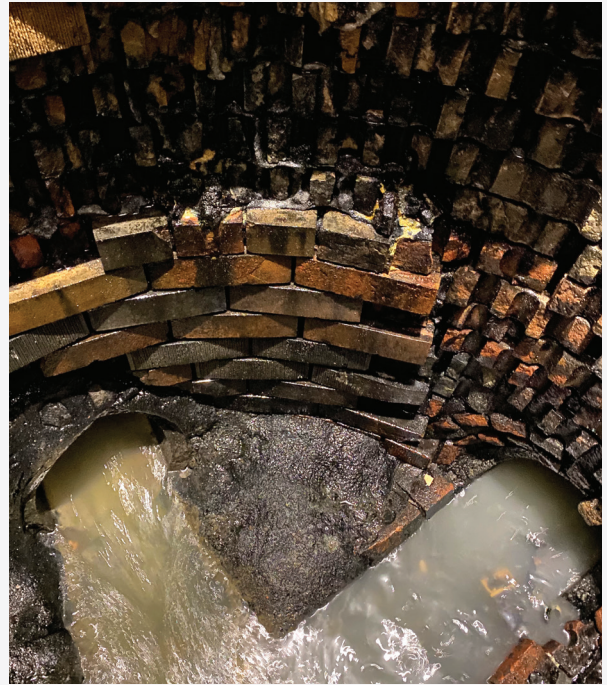
The old manhole had deteriorated to the point where many bricks were missing, corroded and falling apart. A collapse was imminent.

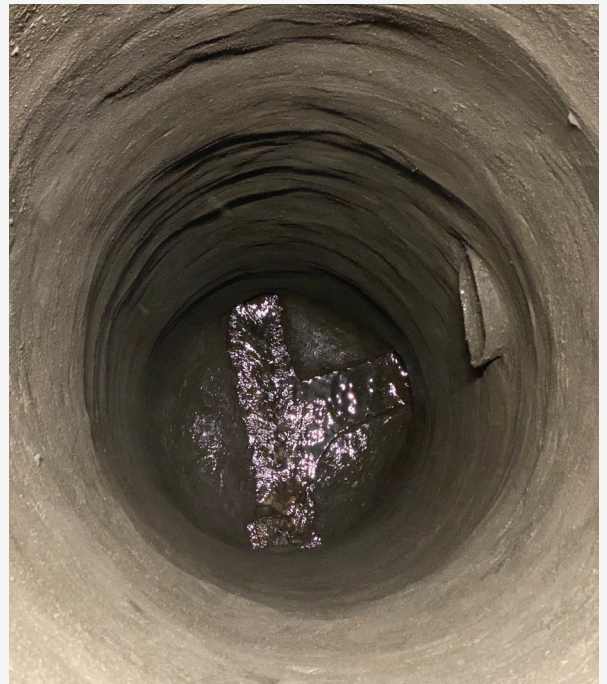
Prior to the application of Structure Guard, a 1" layer of AluminaLiner was applied for structure reinforcement.
