STORM DRAIN SYSTEM RELINED TO PREVENT INFILTRATION OF DIESEL FUEL CAUSED BY SPILL IN KALAMAZOO TRAIN YARD

Quadex® Structure Guard® 100% Solids Epoxy Used to Rehabilitate the Manholes and Catch Basins

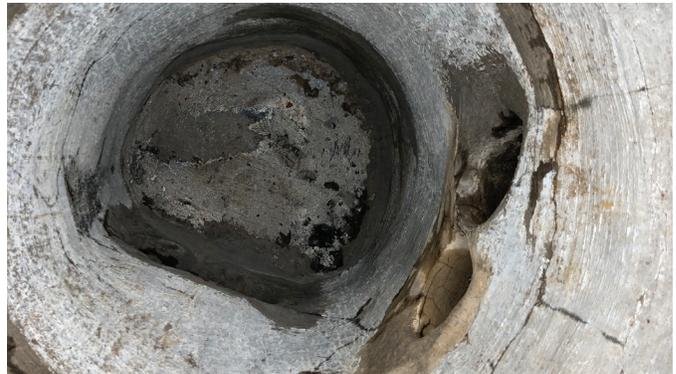
Before lining - cracks and voids are noticeably visible in this leaking manhole.

basins that varied from 5' - 10' in depth. While the contractor performed the necessary CIPP portion of the project, a sub-contractor was hired to reline the manholes and catch basins. From the beginning, there were problems and concerns with the sub-contractor's ability to properly apply the cementitious liner. That initial concern proved to be valid, since the manholes failed several exfiltration tests.

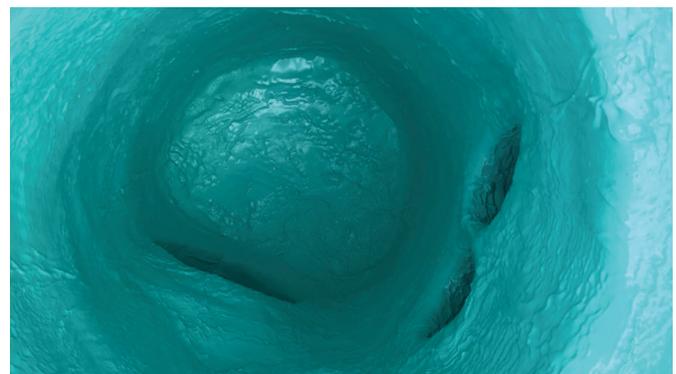
After lining with Structure Guard 100% solids epoxy — smooth troweled for an impermeable, corrosion resistant finish.

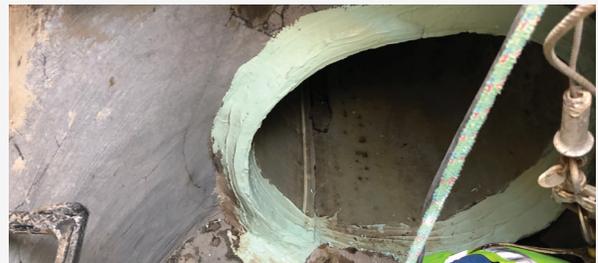
I&I Guard-PRF was applied to fill voids and cracks in manhole and pipe entry points.

Based on previous success in similar environments, Vortex Services recommended Structure® Guard, a 100% solids epoxy coating system, to address and eliminate the potential environmental hazard. Structure Guard® is widely known for exceptional bond strength and its long-term chemical and corrosion resistance. To plug the leaking voids and cracks, I&I Guard®-PRF, a fast-setting water stop product, was also specified.

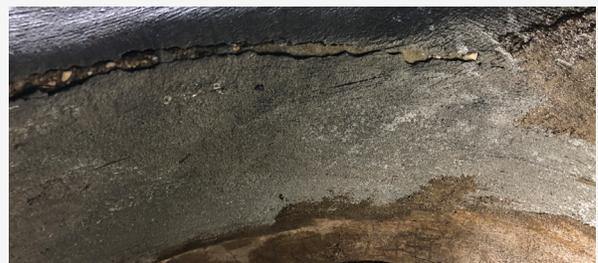
Cracks reveal failed cementitious liner from original project.

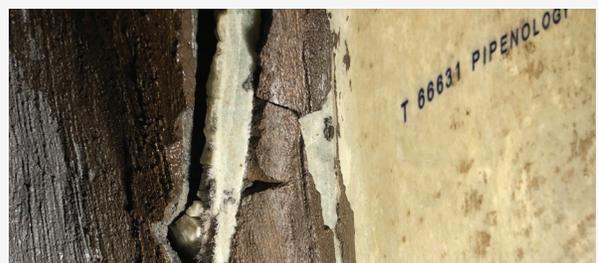
If left unrepaired, cracks like this would have allowed inflow of diesel fuel into the storm drain system.
