## CASE STUDY

## SOUTH ADAMS COUNTY, COLORADO DISTRICT SANITARY SEWER REHABILITATION

Pipe and Manholes Fully Restored  
with Materials Designed to  
Withstand Harsh Winters and  
Extremely Cold Conditions

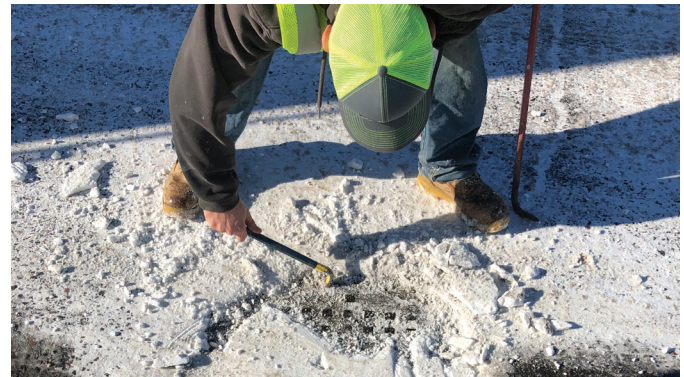
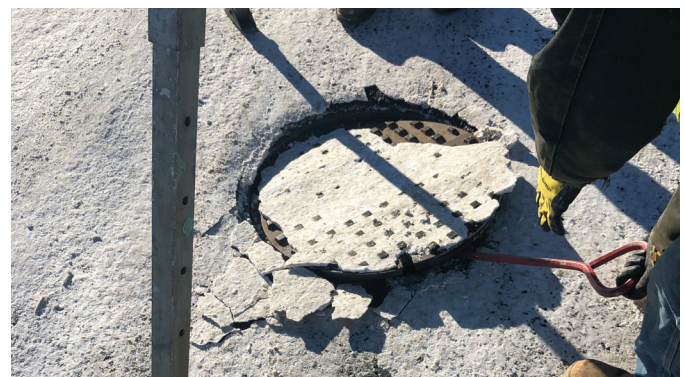
*Cold winter conditions not only impacts the installation crew,  
it takes its toll on the manholes as well.*

During the installation phase, cold weather became a major installation impediment. Although the frigid Colorado temperatures presented many challenges, through careful planning and execution, the crews were able to successfully complete this manhole rehabilitation project.

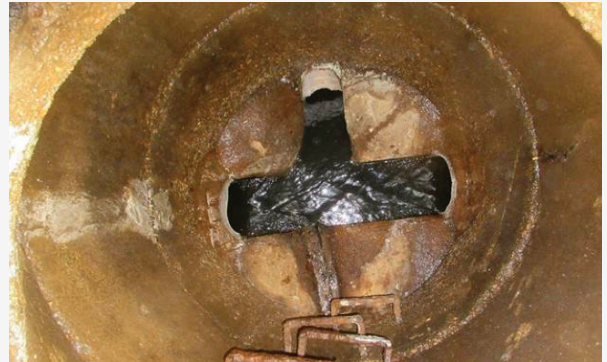
*Typical manhole condition prior to lining with QM-1s Restore.*

To address the pipe and manhole concerns, the engineer and general contractor recommended two courses of action. Clearly the pipe was to be CIPP lined. However, due to the degradation of the manholes, they would require more attention. To address the loss of structural integrity, the manholes would be lined with Quadex® QM-1s Restore®, a cementitious mortar known for its structural restoration properties. The engineer called for Quadex Structure Guard®, a 100% solids epoxy spray, to be applied at a thickness of 125 mils to add the needed corrosion protection.

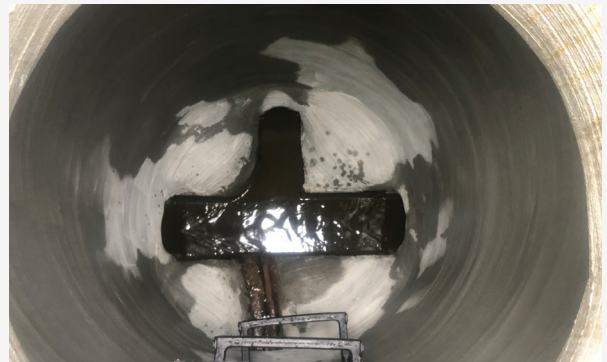
*Manhole lined with QM-1s Restore and ready for Structure Guard epoxy coating for corrosion protection.*

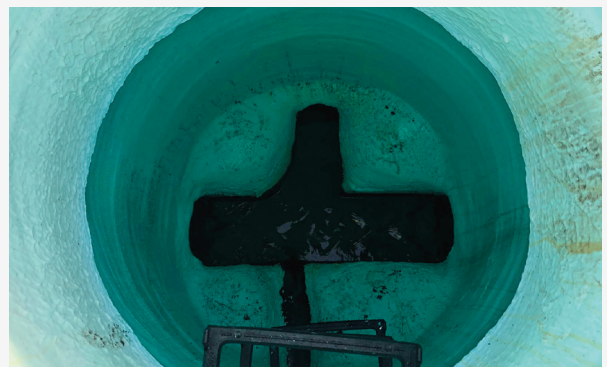
*Structure Guard 100% solids epoxy was applied at 125 mils, to provide corrosion protection.*

Post installation testing of the Structure Guard epoxy revealed adhesion levels that exceeded the expectations of county officials. Visual inspections also showed clean, smooth finished manholes in spite of the less than desirable weather conditions faced by the crew.
