CASE STUDY

Degraded Hoosier Pass Water Transport Flume Relined with Structure Guard® Epoxy To Address Extreme Conditions and Long-term Protection

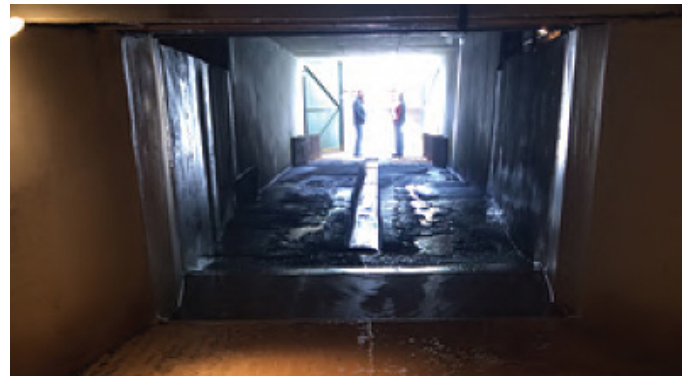
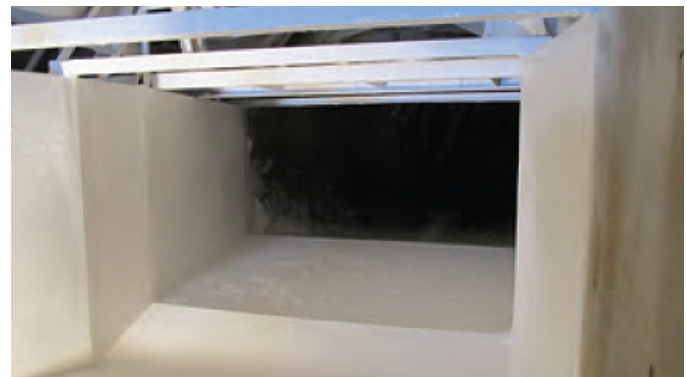
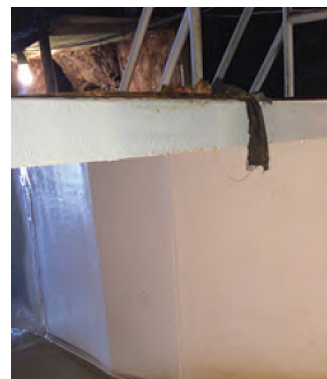
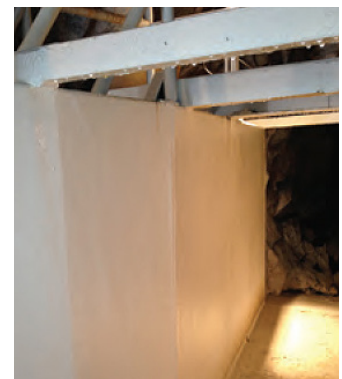
The Hoosier Pass flume operated by the City of Colorado Springs, Colorado, transports water from the western slope through the Continental Divide tunnel to one of the City's reservoirs. Since its construction in 1951, this tunnel has significantly degraded. The expense to replace this steel and concrete structure would be substantial.

The project was recently inspected and after 2 years, no signs of delamination, abrasion or cracking were noted. The previous cracks remained sealed and have not reappeared- even being in such an extreme environment.

The steel portion of the flume was sandblasted and the concrete portion was power washed prior to applying 150 mils to both substrates.
