Outagamie County CTH CE Culvert Rehabilitation

Trenchless Technology Used to Rehabilitate Debilitated Infrastructure Under Four-Lane Highway in Appleton, WI

GEOKRETE GEOPOLYMER MORTAR STRUCTURALLY RESTORES LEAKING AND CORRODED METAL ARCH PIPE

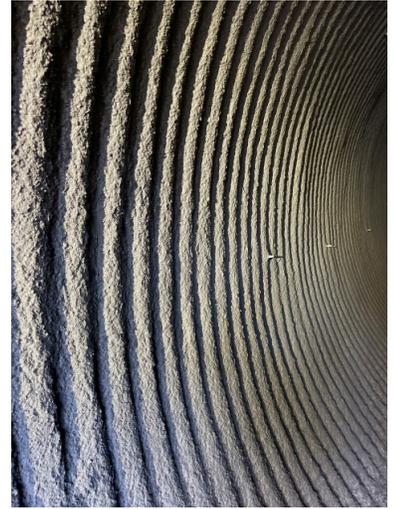
The wall of the culvert before having GeoKrete geopolymer spray applied.

VLS recommended GeoKrete be spray-applied to a thickness of 1.5" over the entire length of the pipe.

Vortex Lining Systems lined the existing pipe with the spray-applied GeoKrete Geopolymer. The application of the Geopolymer mortar not only seemingly solved the rust and deterioration issues for the pipe but upheld the structural integrity of the asset, adding 50 years of service life.

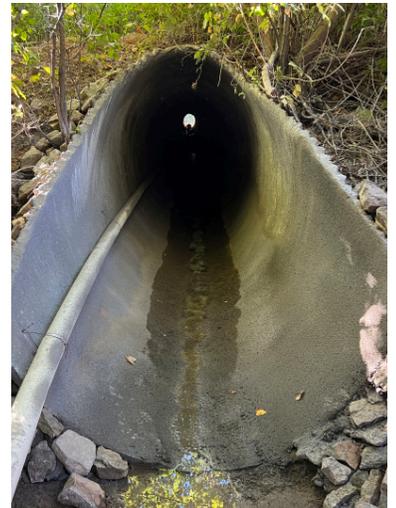
The culvert pipe was fully rehabilitated due to the innovative and efficient spray-on application of GeoKrete Geopolymer.

As the existing pipe ran beneath the county's four-lane highway, there was no traffic disruption. The VLS crew was able to complete clean, prep, patch, and reline the metal arched culvert in just 8 days, with no interruption of traffic flow.
