City of Cocoa, FL – Claude H. Dyal Water Treatment Plant, Ozone Contactor Tanks

Rehabilitation of Damaged and Degraded Ozone Contactor Tanks

CITY OF COCOA, FLORIDA ENGAGES VORTEX TO REPAIR SEVERELY DAMAGED OZONE CONTACTOR TANKS UTILIZING ADVANCED COATINGS AND GEOPOLYMERS FOR CORROSION AND STRUCTURAL INTEGRITY

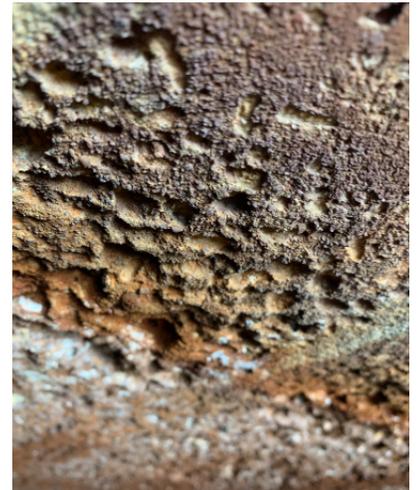
Before

11 chambers, totaling 25,982 square feet of Ozone Contactor tanks were suffering from extreme corrosion and degradation due to the harsh environment. If the degradation was allowed to continue, the structure could have leaked or become structurally compromised.

The Ozone Contactor tanks had significant degradation and required immediate attention to prevent further structural compromise and possible water quality issues. Because the tanks are essential to water treatment operations, downtime needed to be minimized, ruling out a costly and time-consuming replacement option.

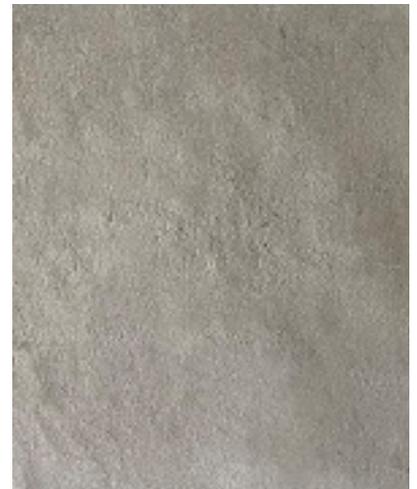
After

- Geopolymer Lining: 1.5-inch application of GeoKrete®-Water across all 11 chambers
- Epoxy Lining: 125 mils of Structure Guard® - Water Epoxy applied as a protective topcoat in influent chambers
- Total Coverage: 25,982 sq. ft. rehabilitated, including 2,496 sq. ft. with dual-layer protection
