PROJECT
City of Houston

CONTRACTOR
Vortex Lining Systems - Houston, Texas

DIMENSIONS
5,600 LF of 60-inch RCP

Geopolymer Lining System Used to Structurally Rehabilitate Deteriorated 60-Inch Sewer Pipe Running Beneath Metrorail System in Houston, TX

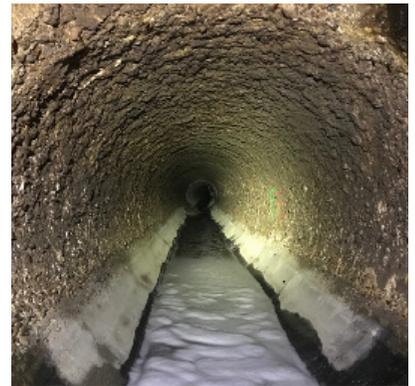
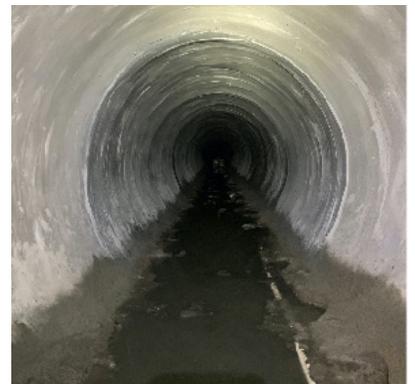
Since the sewer line ran beneath several intersections along Fulton Street and many of the manholes were located between the tracks, the unique challenge on this project was how to work around the light rail system.

After cleaning and extensive patch and repair of the leaking sewer line's cracks, voids and offset joints, Vortex applied GeoKrete geopolymer to a 1.5" design thickness. GeoKrete is formulated to provide excellent corrosion protection in high hydrogen sulfide environments and restore structural integrity, once fully cured.

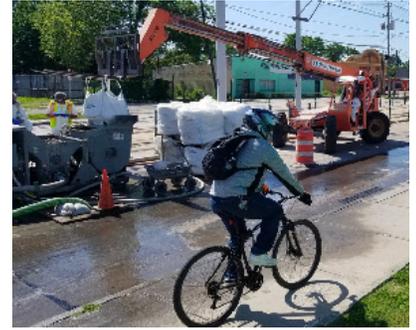
Vortex was able to rehabilitate the 60" sanitary sewer line running beneath a section of the City's light rail train tracks.

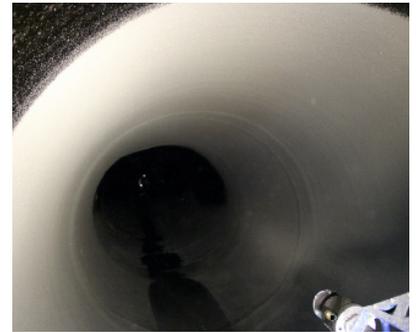
Example of the QLS spin-casting process, where GeoKrete can be applied to a multitude of surfaces for superior corrosion protection and fully structural rehabilitation of the affected pipe or structure.

Due to the versatility of the GeoKrete material, Vortex was able to both spray apply and spin-cast the material using application equipment.
