CASE STUDY

Multiple Trenchless Technologies Used to Rehabilitate Aging Infrastructure on Liberty Island, Home of the Statue of Liberty

UV CIPP LINER AND GEOKRETE® GEOPOLYMER MORTAR STRUCTURALLY RESTORES MANHOLES AND RELINES AGING SEWER LINER WITHOUT THE NEED FOR DIGGING

Liberty Island Trenchless Sewer Rehabilitation

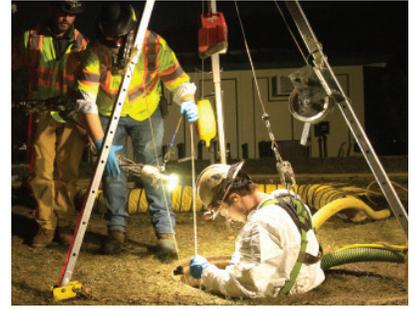
Vortex Services installation crew inserting the UV light chain into the manhole to begin the UV curing process.

The process included jet cleaning and prepping the sewer line and manholes for rehabilitation. For the manholes, GeoKrete® Geopolymer was spray-applied to approximately 1" thick, troweled, and brushed to a smooth finish to restore full structural integrity. The sewer pipe was relined using the UV CIPP process, which was recommended for its environmentally friendly design and quick cure ability given the limited time the crew had to install each night.

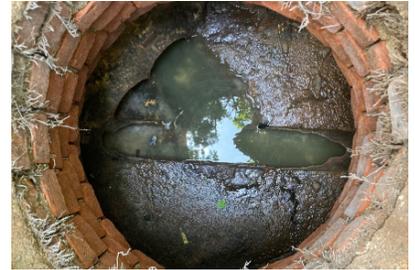
Manholes were deteriorated and leaking.

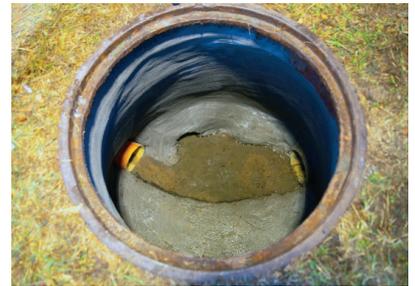
GeoKrete Geopolymer was applied to structurally reinforce the manhole.

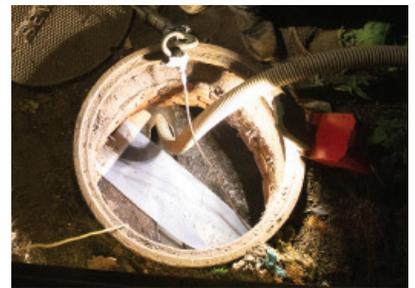
A glider foil, installed prior to inserting the UV liner, reduces friction during liner pull-in process.

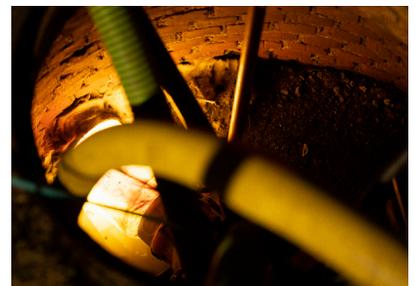
Liner being cured with UV light chain.
