CASE STUDY

PROJECT OWNER
City of Victoria

CONTRACTORS
Vortex Companies & Victoria Drains

Manhole Repair in Victoria, BC

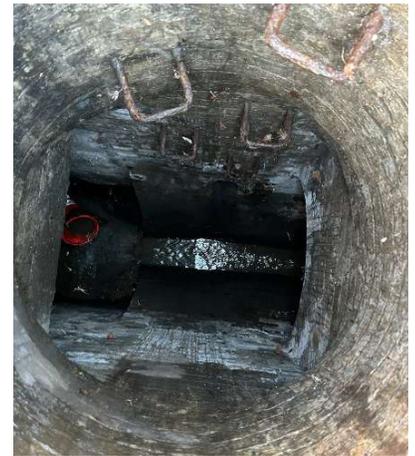
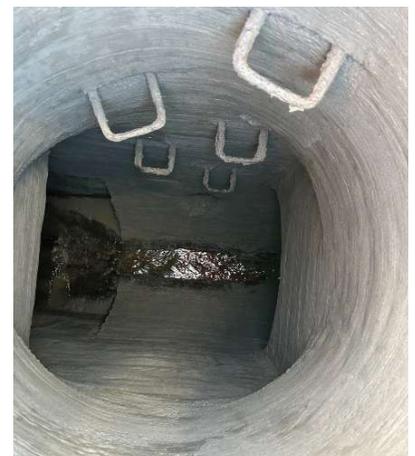
In early 2024, the City of Victoria, British Columbia, Canada conducted an annual inspection of its manholes and noticed that a number of them were on the decline. In total, 66 manholes were found suffering from degradation from H₂S gas, root intrusion and cracks causing I & I, that rendered them ineffective; their channels and benching were in particularly poor shape. When Victoria put this project out to bid, Vortex Companies, working in tandem with local drainage services provider Victoria Drains, presented their proposed rehabilitation plan and solutions to the City. The City was impressed with the cost savings and ease of installation associated with the team's proposal, and selected Victoria Drains and Vortex to repair this essential infrastructure.

As part of this collaboration, Vortex supplied the repair products, a sprayMASTER® mortar application rig, along with training and technical support, while Victoria Drains handled traffic management plans and supplied in-house traffic control workers. Beginning in October, the crew removed debris from the manholes as necessary and then carefully inspected each asset.

After cleaning the manholes, the team applied Quadex® Quad-Plug® to repair and restore broken or missing sections of the trough and bench. Hyperform®, rapid-set patching material was then used to fill shape the bench and fill voids in the chimney.

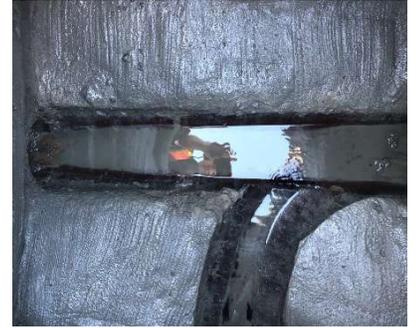
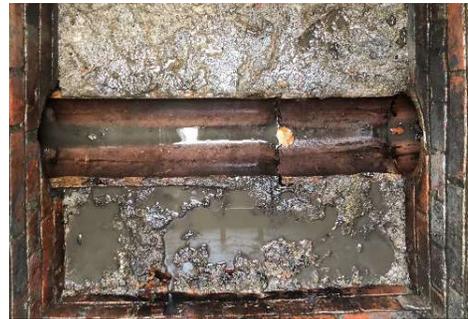
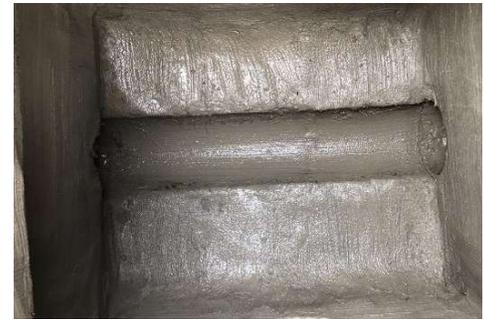
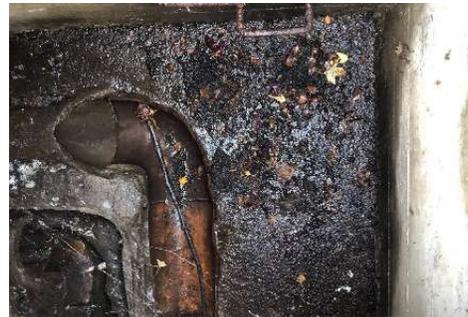
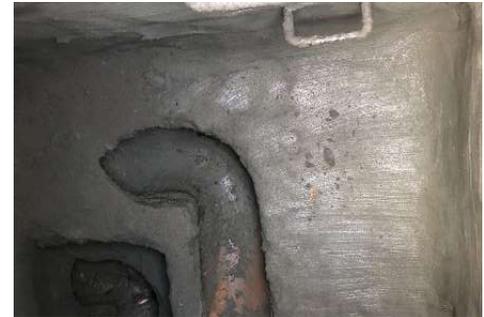
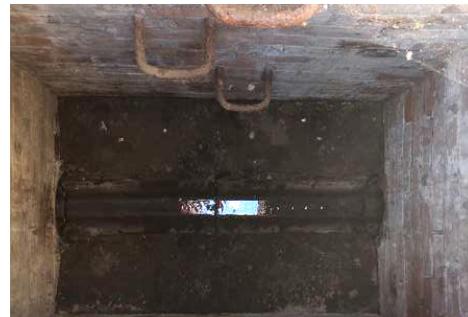
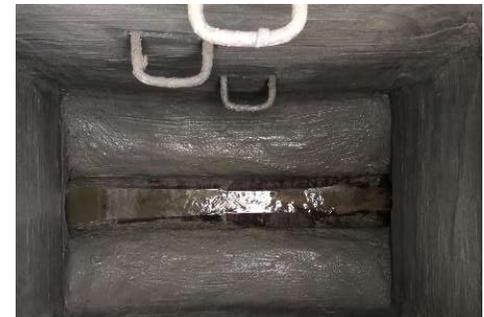
Finally the team spin-cast and spray-applied approximately one inch of Quadex® GeoKrete structural geopolymer mortar onto each one to restore their structural integrity. Once troweled to a smooth finish, the manholes were ready for service in less than 24 hours. pleased with the group's efforts.
