CASE STUDY

Ak-Chin Indian Community,
Maricopa Indian Reservation
Manhole Rehabilitation, Maricopa, AZ

Quadex® Structure Guard® Add a New Life to Manholes on Ak-Chin Indian Reservation

100% SOLIDS EPOXY COATING PREVENTS CORROSION, I & I AND SAVES MONEY.

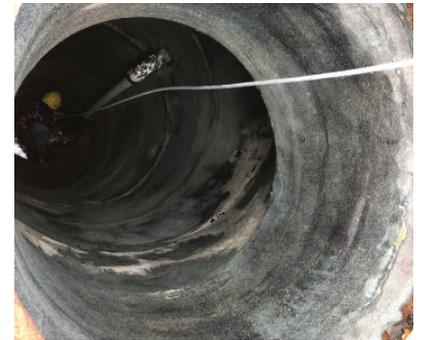
Manhole cleaned and prepped, awaiting structural and corrosion protection.

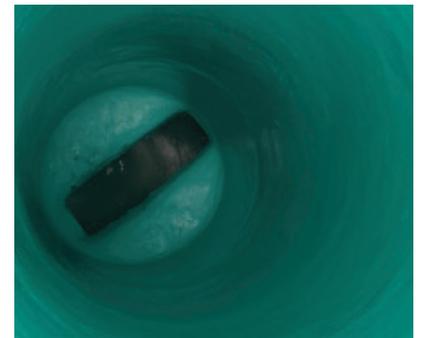
Completed manhole after Structure Guard® spray-applied and troweled to a smooth finish.

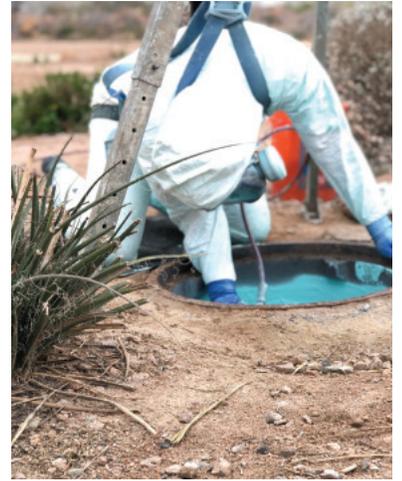
Structure Guard is easy to apply and allows crews to quickly complete multiple structures in a single day.

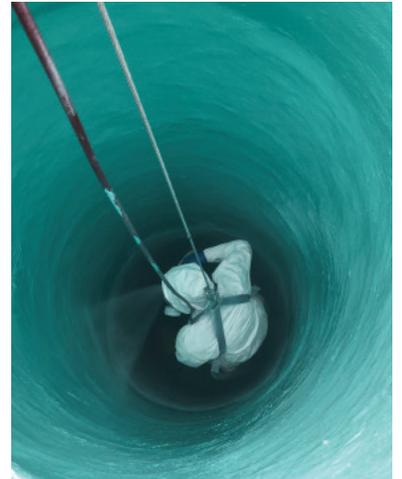
Structure Guard can be applied up to 250 mils per pass.
