CASE STUDY

- Grand Chute-Menasha West
- Interceptor lines-manhole relining

Manholes Rehabilitated with GeoKrete® Still Looking Good After 10 Years.

SAME MANHOLES ORIGINALLY LINED WITH POLYUREA COATING FAILED AFTER ONE YEAR.

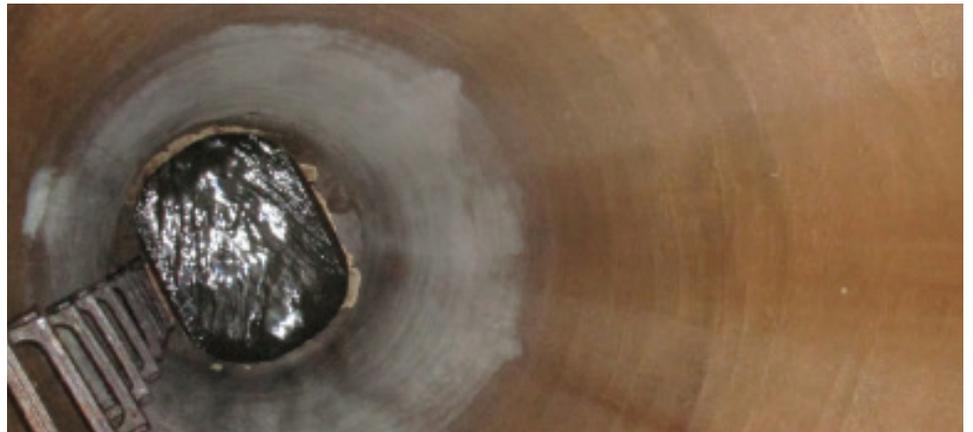
2016

Same manholes 10 years after being relined with GeoKrete.

Rodney Manthey, from the Grand Chute-Menasha West Sewer Commission recently inspected the same manholes and reported that after 10 years the manholes show no signs of failure and are still in excellent condition.

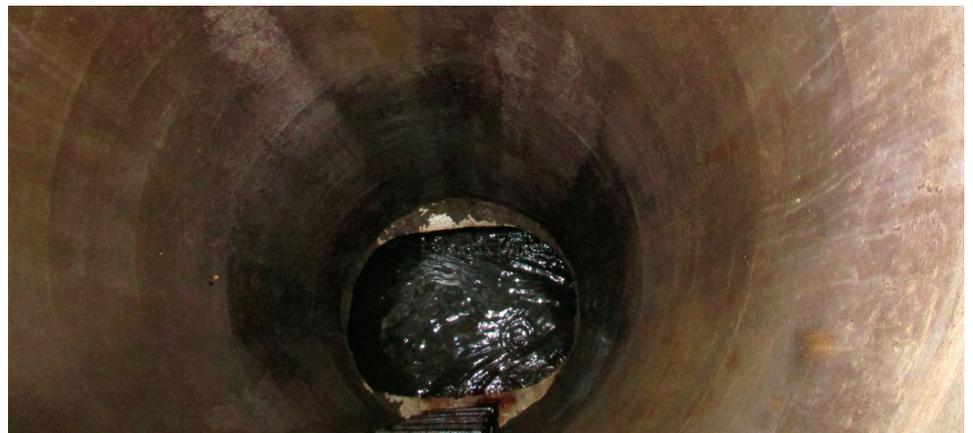
No visible evidence of manhole deterioration.

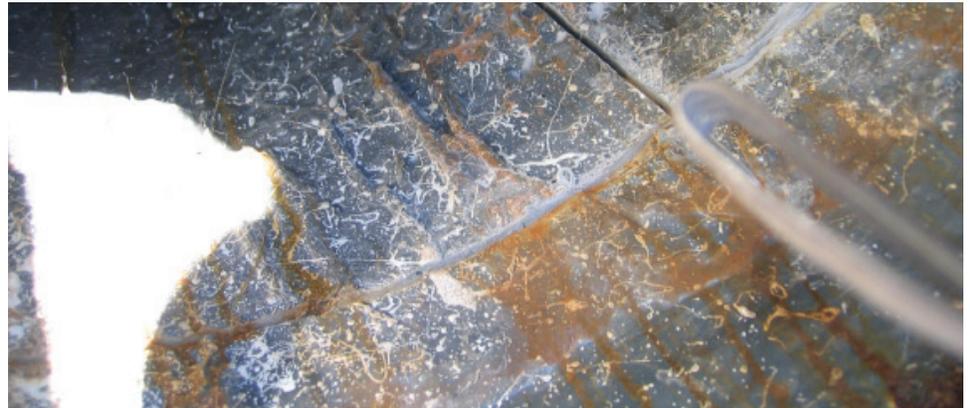
In 2006 an annual inspection of manholes on Butte Des Morts Beach Road in Neenah, WI, revealed a lining failure of more than a dozen manholes that had been rehabilitated with a polyurea coating just one year prior. Extensive flaking and peeling was already present indicating a complete failure was imminent.

Polyurea coating peeled and flaked, exposing the concrete manholes to hydrogen sulfide gas and consequential corrosion.

Rather than re-coat the manholes with the same material, the Grand Chute-Menasha West Sewer Commission instead chose to reline them with a much more robust material, GeoKrete® Geopolymer, manufactured by Quadex LLC., as recommended by a local manhole rehabilitation specialty company, Hydro-Klean (formerly Infratech).

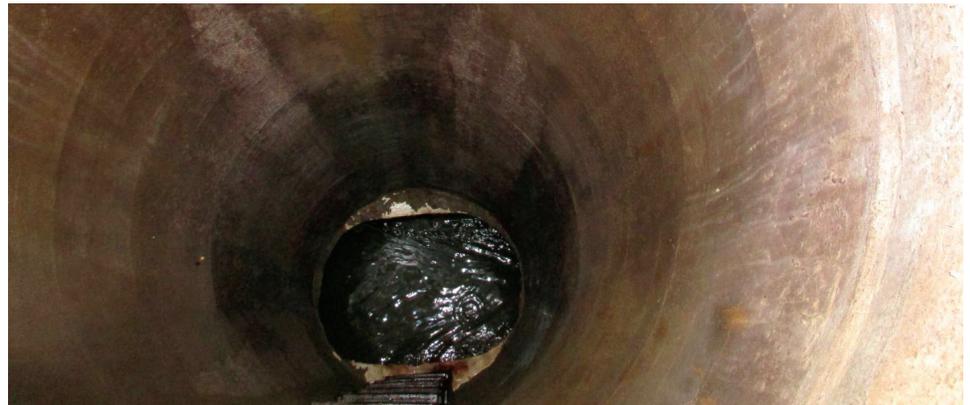
Failed Polyurea coating was removed before new GeoKrete coating was applied.

Once the manholes were properly prepped, GeoKrete was applied using a spin-casting apparatus to ensure a consistent and even coating from top to bottom. Only one pass was required for specified coverage. Then the contractor used trowels to smooth out the finish. GeoKrete has an excellent cure rate, and the manholes do not have to be taken out of service.
