## CASE STUDY

# Quadex® Structure Guard® 100% Solids Epoxy Used to Rehabilitate the Manholes and Catch Basins

## STORM DRAIN SYSTEM RELINED TO PREVENT INFILTRATION OF DIESEL FUEL CAUSED BY SPILL IN KALAMAZOO TRAIN YARD

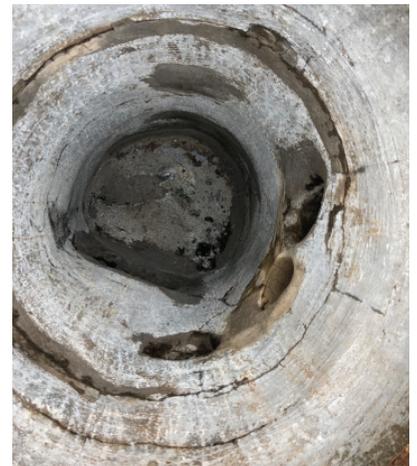
- Local diesel fuel spill leaking into storm drain leading to nearby river
- Previously applied cementitious coating failed, cracked and leaking

*Before lining - cracks and voids are noticeably visible in this leaking manhole.*

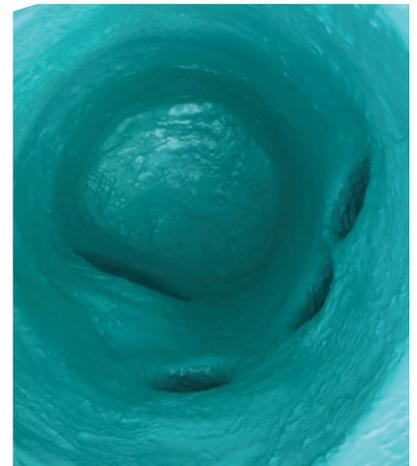
*After lining with Structure Guard 100% solids epoxy – smooth troweled for an impermeable, corrosion resistant finish.*

Based on previous success in similar environments, Vortex Services recommended Quadex® Structure Guard®, a 100% solids epoxy coating system, to address and eliminate the potential environmental hazard. Structure Guard is widely known for exceptional bond strength and its long-term chemical and corrosion resistance. To plug the leaking voids and cracks, I & I Guard®-PRF, a fast-setting water stop product, was also specified.

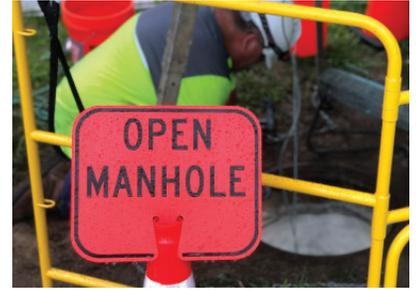
*Vortex Services crew applies Structure Guard®*

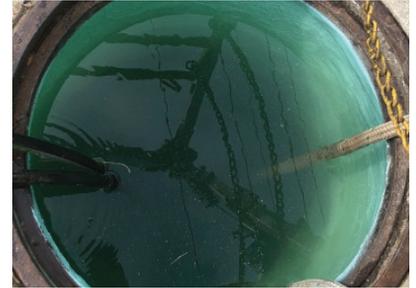
*Lined manhole is filled with water for leak (exfiltration) testing. No leaks present.*

Once completed, the newly-lined manholes and catch basins were tested for infiltration and exfiltration. In each case, they exceeded the testing standards.

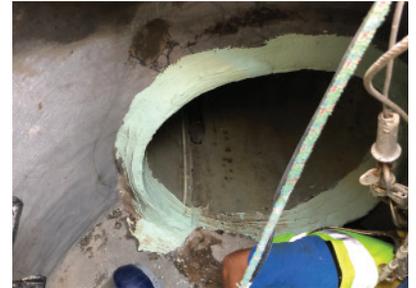
*I & I Guard-PRF was applied to fill voids and cracks in manhole and pipe entry points.*

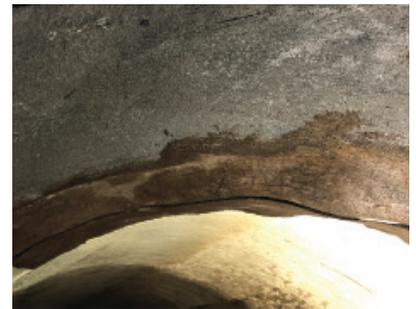
*Cracks reveal failed cementitious liner from original project.*

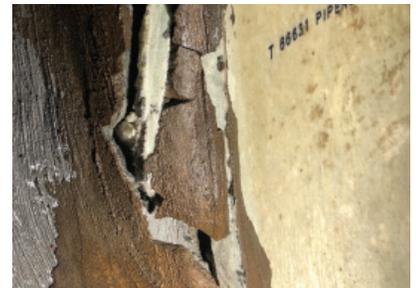
*If left unrepaired, cracks like this would have allowed inflow of diesel fuel into the storm drain system.*
