City of Lakewood, OH

Superior Performance Properties of GeoKrete® Geopolymer Structurally Restores and Protects 100+ Year-Old Sewer

129' DEEP MANHOLE AND 350' LONG EGG-SHAPED OUTFALL PRESENTED SEVERAL CHALLENGES

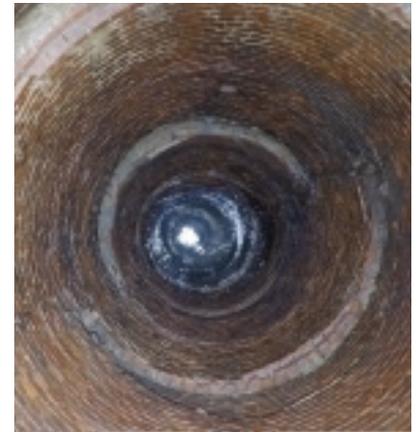
Multiple baffles had to be removed prior to rehabilitating the noticeably cracked 125' deep manhole.

In addition to standard prep, which included pressure washing and patching of cracks and gaps, 15 crumbling concrete baffles built into the walls of the deep manhole had to be removed. The large voids created by their removal also had to be reinforced and filled. To accomplish this, a two-man crew was lowered into the manhole in a basket operated by a crane. This same procedure was used to apply the GeoKrete during the application process.

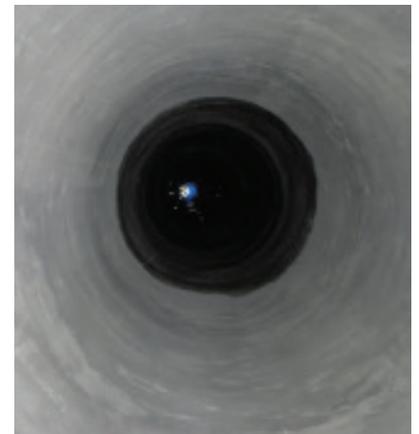
Manhole after QLS GeoKrete lined.

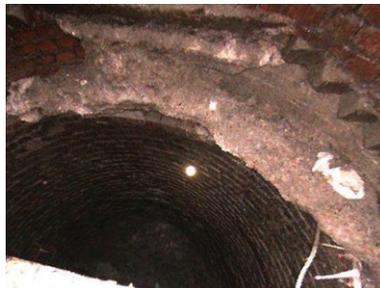
15 concrete baffles, like this damaged one shown, had to be removed from the manhole.

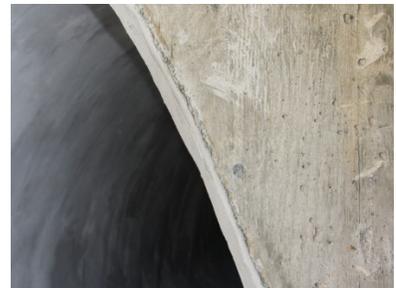
GeoKrete creates a new corrosion resistant and fully structural lining.

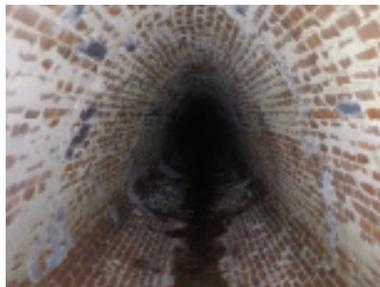
Before: Egg-shaped brick outfall.

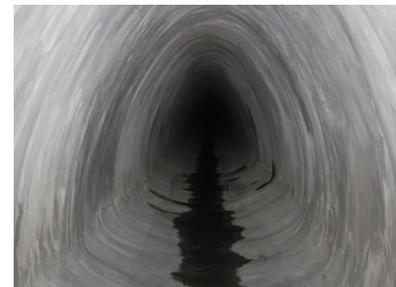
After: Outfall lined with QLS GeoKrete.

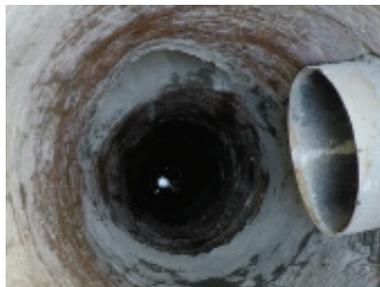
Before: Total restoration was required to bring the sewer back to original operating conditions.

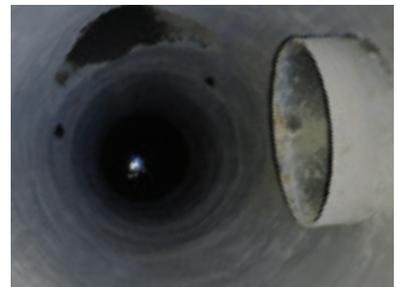
After: Manhole completely restored and fully structural with QLS GeoKrete.
