University of Pittsburgh –
5th Avenue Steam Tunnel
Rehabilitation (Pittsburgh, PA)

Corroded Steel Plate Tunnel, Buried in Front of the Cathedral of Learning, Structurally Restored Via Innovative Trenchless Solution

50 YEAR-OLD, DETERIORATED STEAM TUNNEL ON UNIVERSITY OF PITTSBURGH CAMPUS STRUCTURALLY REHABILITATED WITH GEOKRETE® GEOPOLYMER

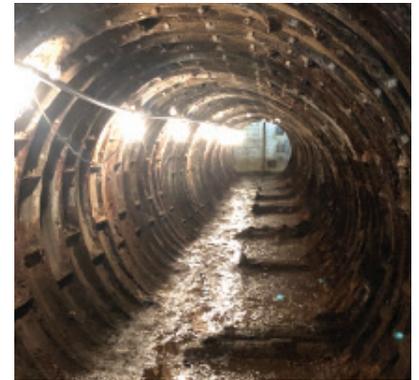
Condition of steam tunnel proper to QLS GeoKrete® installation.

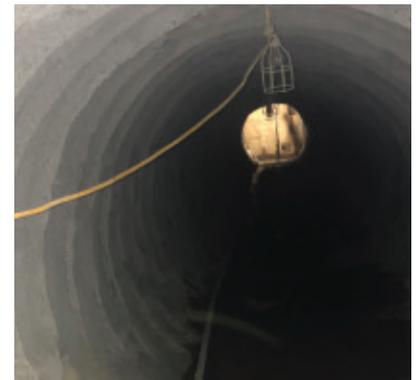
After the steam tunnel is lined with GeoKrete and floor leveled with Quad-Flow.

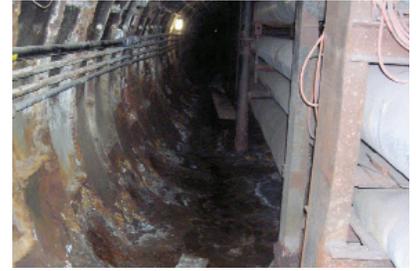
Condition of the tunnel and placement of the conduit prior to removal and rehabilitation.

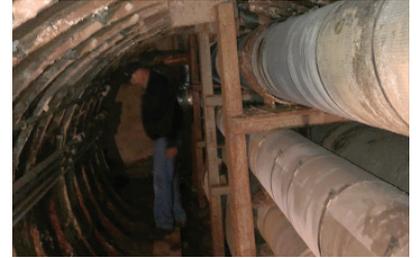
Severe corrosion threatened the structural integrity of the old steam pipe.

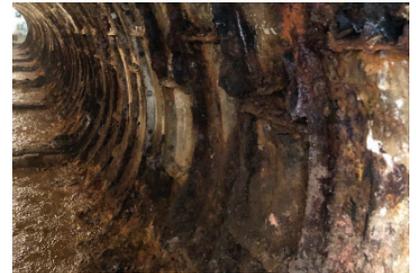
The old piping and conduit was removed prior to relining the tunnel with QLS GeoKrete.

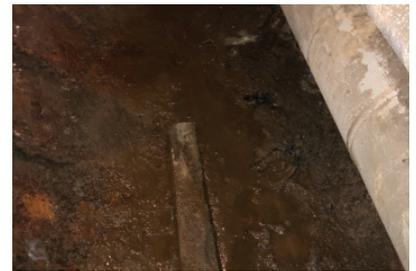
The original rounded floor of the steam tunnel was not only slippery, it was difficult for maintenance crews to gain purchase.

Prior to the lining process, all piping and brackets needed to be removed. It was also determined that the invert of the pipe needed to be raised 1.5" and then leveled to a flat surface bottom to make it safer for maintenance crews to walk through the tunnel in the future.

To achieve this, the QLS crew recommended Quadex Quad-Flow for its high-build, self leveling properties. Once the floor was cured, Wayne Crouse was ready to install the supports for brackets and piping. QLS then lined around these supports, allowing them to follow with bracket and piping installation.

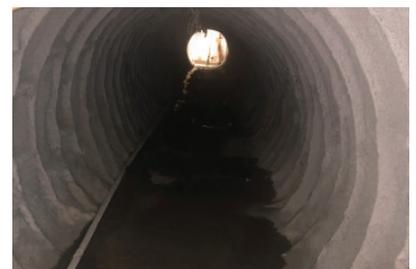
After 1.5" of QLS GeoKrete was spray-applied to structurally renew the deteriorating steam tunnel.
