## CASE STUDY

Queens, NY Sewer Interceptor Rehabilitation Project

## GEOPOLYMER RELINING AND STRUCTURAL RESTORATION OF AGING SEWER INTERCEPTORS IN QUEENS, NY

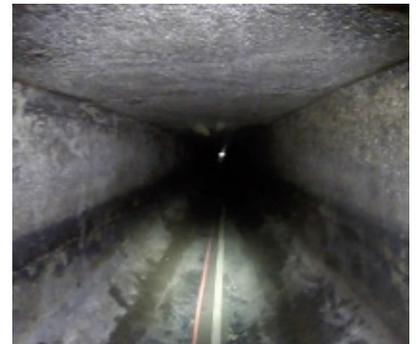
Box Culvert prepped for lining.

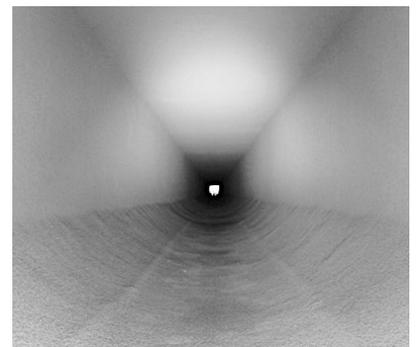
Box Culvert after GeoKrete Geopolymer lining.

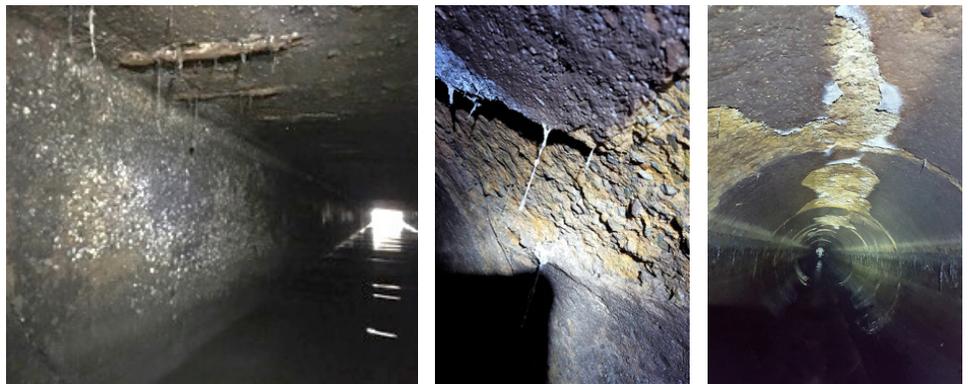
*An aging sewer infrastructure combined with severe corrosion and the negative impact from Hurricane Sandy led to a major rehabilitation and structural restoration effort.*
