CASE STUDY

South Adams County Water District, Commerce City, CO

Pipe and Manholes Fully Restored with Materials Designed to Withstand Harsh Winters and Extremely Cold Conditions

FAILED T-LOCK LINED MANHOLES REHABILITATED WITH STRUCTURE GUARD® 100% SOLIDS EPOXY

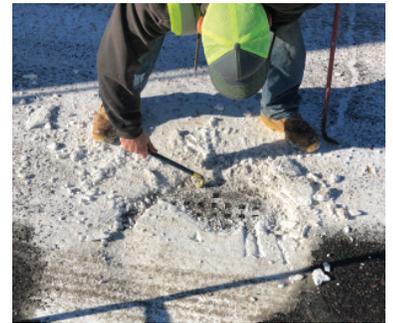
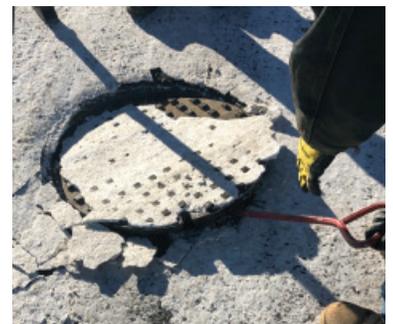
Cold winter conditions not only impacts the installation crew, it takes its toll on the manholes as well.

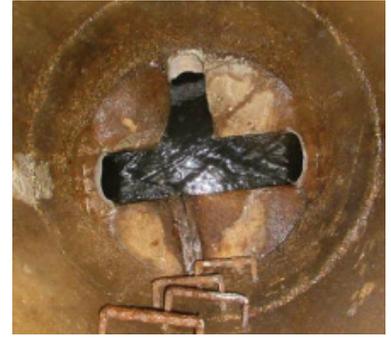
Typical manhole condition prior to lining with QM-1s Restore.

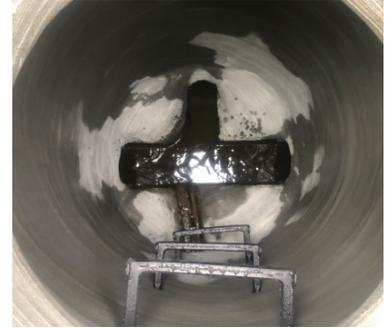
Manhole lined with QM-1s Restore and ready for Structure Guard epoxy coating for corrosion protection.

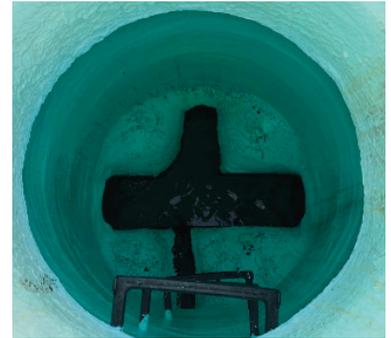
Structure Guard 100% solids epoxy was applied at 125 mils, to provide corrosion protection.
