PROJECT
GeoKrete® Manhole Rehab Trial

OWNER
City of Shreveport

GeoKrete® Selected for Manhole Rehabilitation Test and Exceeds Expectations

MANHOLE REHABILITATION PILOT TEST SHREVEPORT, LA

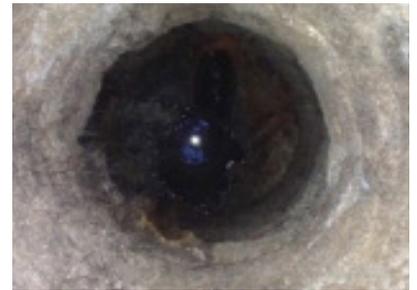
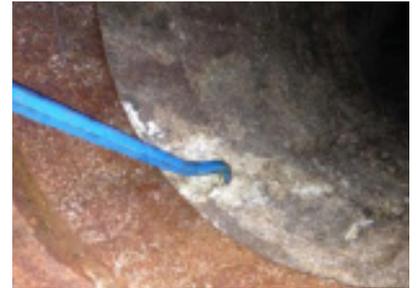
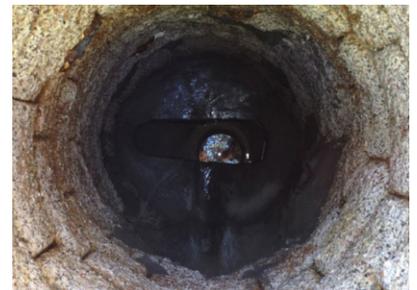
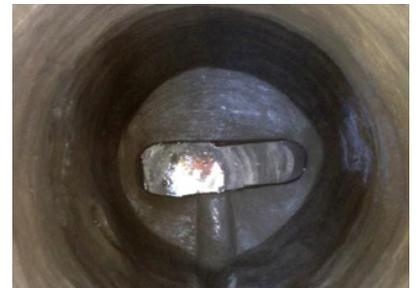
This was a highly corroded manhole picked by the City of Shreveport as a trial / demonstration for Quadex® GeoKrete®, a structural, corrosion resistant geopolymer mortar. This manhole was approximately 10 feet in depth and had a forcemain dumping in. The manhole was in desperate need of a structural lining system with extreme corrosion resistant properties.

A 4,000 psi water blast to clean the substrate. The City of Shreveport provided a Vac truck to help remove the enormous amount of gypsum that was cleaned from the manhole walls. All mortar between the concrete blocks was gone due to MIC (microbiologically induced corrosion). Quadex utilized its rapid setting patching material, Hyperform®, to rebuild the bottom and create a flow channel for the incoming force main.

Quadex utilized its GeoKrete geopolymer mortar to structurally restore this manhole to a "better than new" state. The liner averaged 1 1/2" in thickness with having to apply it upwards of 4" in some places.
