**CASE
STUDY**

Brevard County, FL — South Beaches Sewer and Manhole Lining Installation

COUNTY SEARCHING FOR MANHOLE REPAIR SOLUTION TO STOP INFILTRATION, RESTORE STRUCTURAL INTEGRITY

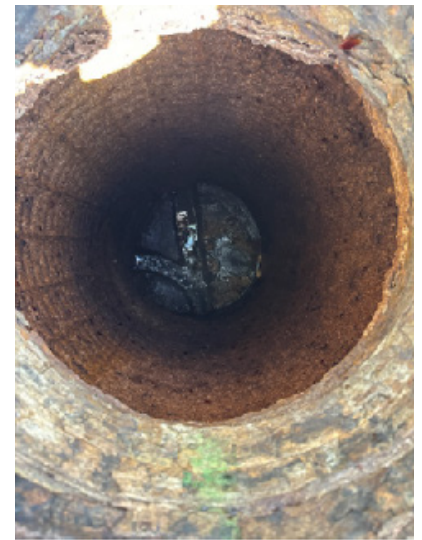
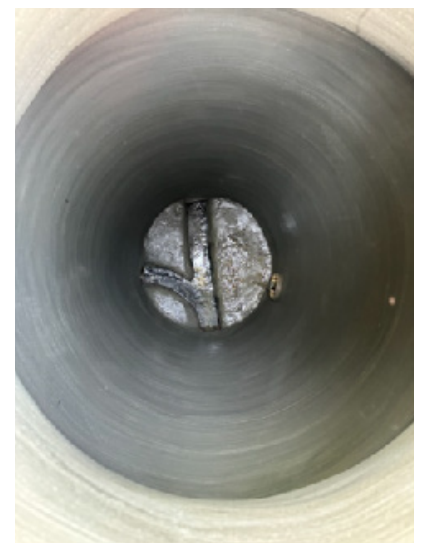
To ensure a long-term rehab solution required to restore the structural integrity of the 186 affected manholes (total of 1500 VF) manhole preparation is key. The Vortex Services crew first used high-pressure water, sand blasting, and other mechanical methods to clean the manholes and remove any materials that hindered their functionality. I & I Guard®-SCF 200 polyurethane injection grout was then used to seal off large cracks and voids, while I & I Guard®-PRF polyurethane grout was injected to stop high-flow infiltration.

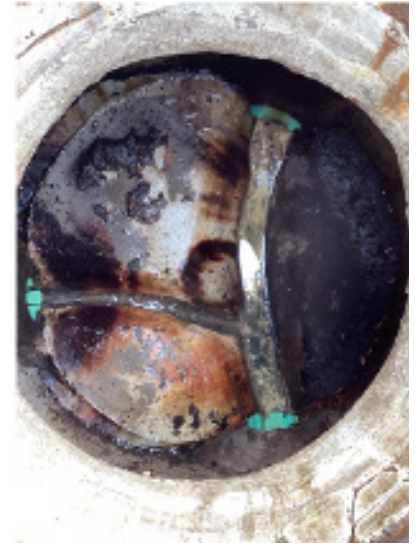
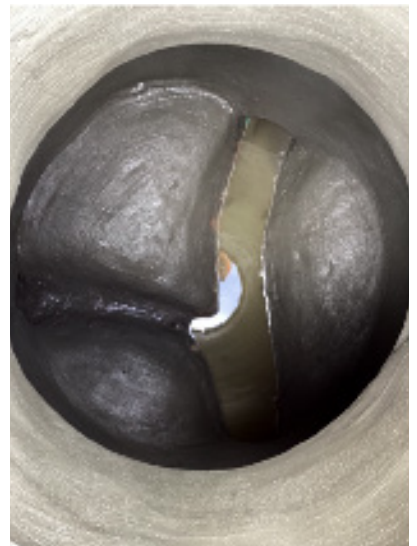
Finally ready for lining, the team then spray-applied the manholes with Quadex® GeoKrete® geopolymer. In addition to restoring structural integrity, GeoKrete is extremely corrosion resistant, even during high exposure to hydrogen sulfide.

To address I & I in the manhole chimney sections, the team installed Chimney Guard™ Epoxy Urethane Hybrid, a flexible and durable chimney seal. In manholes where the corrosive environment was more aggressive, a topcoat of Structure Guard® 100% solids epoxy, which is known for its extreme corrosion resistance, was applied.

During the installation process, the crew faced several unique challenges. Along with battling active infiltration and managing high-volume traffic around worksites, they had to prepare internal manhole surfaces for installation in some very wet areas. The team also had to navigate hard-to-access easements and fenced backyards.
