**CASE
STUDY**

Sewer Condition Assessment in Lewiston, ME

CITY LOOKING FOR SANITARY SEWER INSPECTION SOLUTIONS

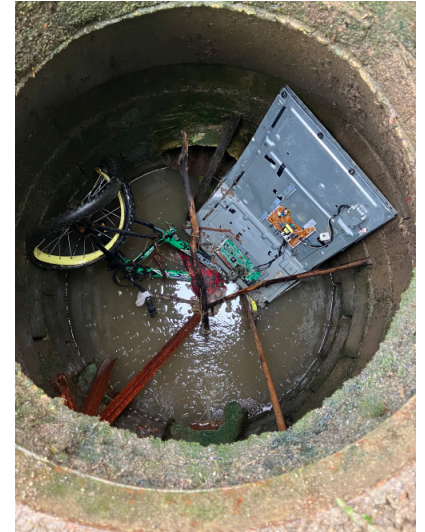
To kick off the project, the Vortex Services crew pre-cleaned the sewer lines, which vary from 4" to 48" in diameter. Next, they assessed 3,000 linear feet of sewer using Multi-Sensor Inspection (MSI) equipment, which utilizes a combination of sonar, HD CCTV, and 2D lidar technology. Together, these tools measure and denote pipe defects, measure pipe conditions and profile above the flow level, and measure debris below the flow level. Once the MSI service was complete, the team then assessed the remaining sewer sections and several manholes using CCTV inspection cameras.

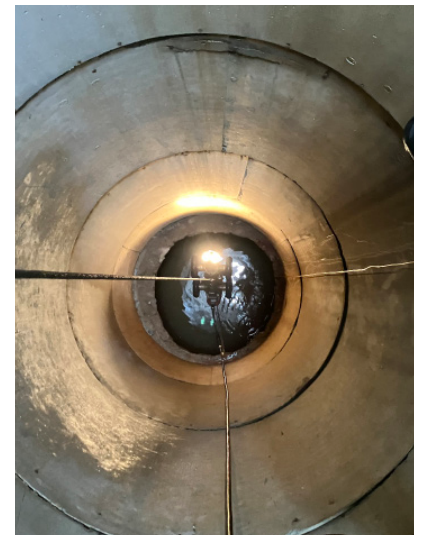
While inspecting, the crew ran into several remote, overgrown drainage easements. Lewiston's Public Works Department took on removing the debris and plant material to create access points where able while the team set up tracked easement machines and ran remote CCTV camera inspections. When the inspection scans were complete, the crew passed them along to the Vortex Data Team, who then analyzed the data and coded it for asset defects and other condition observations.
