**CASE
STUDY**

Multi-Sensor Sewer Interceptor Inspection in Indianapolis

UTILITIES PROVIDER IN SEARCH OF A CONDITION ASSESSMENT SOLUTION FOR AN INTERCEPTOR

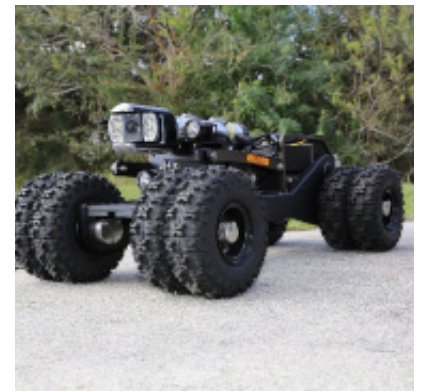
As part of this multi-sensor inspection (MSI) project, which began in March 2023, the Vortex Services team utilized CUES’ SoLID FX large pipe inspection system. This MSI system uses 2D lidar, sonar, and HD CCTV technology, and measures and documents pipe defects, measures actual pipe conditions and profile above the pipe’s flow level, and quantifies and measures debris below the flow level, respectively.
