Maverick Stabilization Grout Stops Soil Erosion and Preserves Seawall

PROJECT
Tampa Area Condominiums & Townhomes

PROBLEM
Several oceanfront condominium seawalls exhibited erosion and multiple depressions due to age and environment.

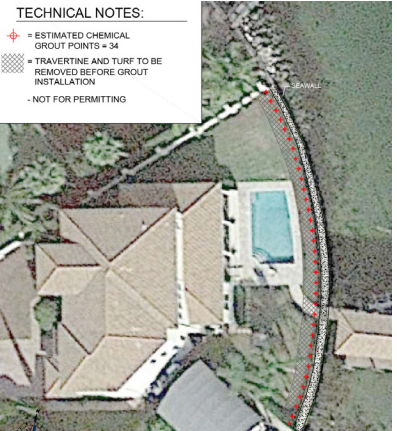
Injection port, to install Maverick Stabilization Grout, identified along condo property seawall, will fill voids caused by erosion and prevent seawall from collapse.

The chemical grout was not only used to fill depressions and voids, but also to compact the ground – an important step that creates a protective barrier behind the seawall to prevent soil migration into the ocean.

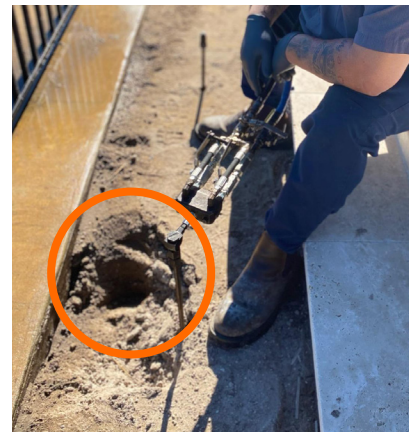
As technician injects Maverick Stabilization Grout into void behind seawall, signs of soil erosion were evident.

Relying on its deep expertise, Vortex Companies advised the contractor on the project to apply Maverick Stabilization Grout two-part chemical grout to prolong the seawall's life and prevent further soil erosion.

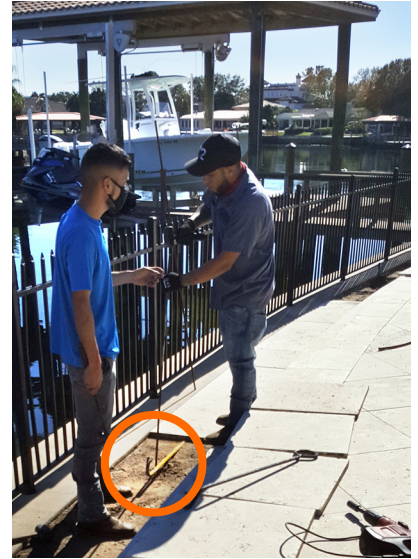
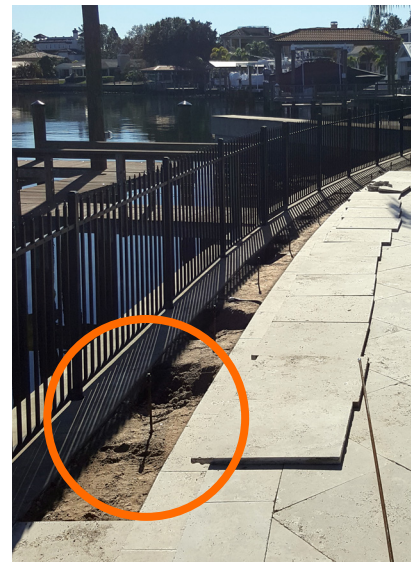
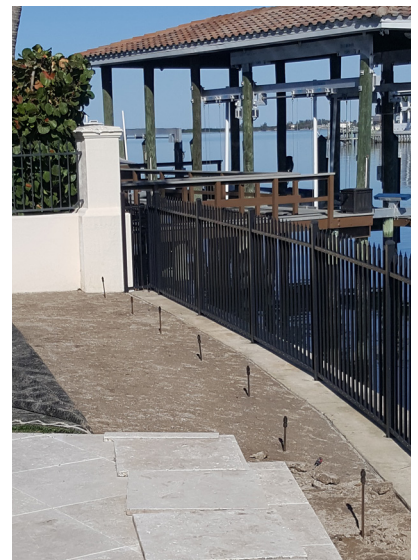
Pilot holes are drilled along top and sides of seawall, where Maverick Stabilization Grout will be applied. No digging or replacement of backfill of seawall was required.
