BRICK SEWER REHAB NEAR MASS GENERAL HOSPITAL

Pipe Relining Eliminates Need To Dig Up Old Brick Sewer Near Hospital's Entrance

- BWSC Westside Interceptor

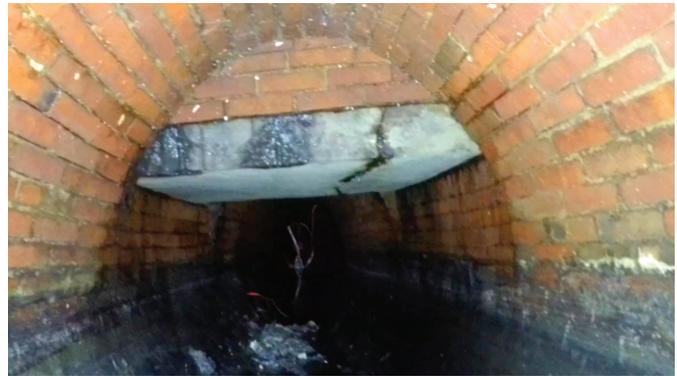
Before: The effects of age and corrosion caused the brick sewer to leak in critical sections of this tunnel, including three headwall obstructions.

RJV Construction was awarded the contract to perform the work by offering two trenchless solutions to rehabilitate the old sewer. CIPP was recommended for the round sections where conditions and access were favorable. However, there were three sections of the sewer where concrete beam “obstructions” prevented the sewer from being CIPP lined. For these areas an alternative method of rehabilitation was required.

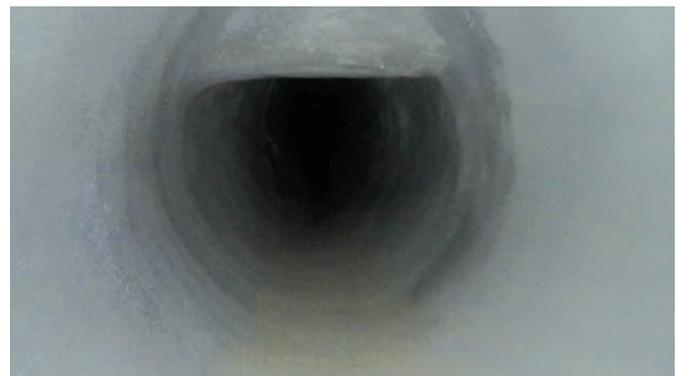
After: 1.75" of QLS GeoKrete was spray-applied to the non-round areas of the tunnel and delivered the required structural and corrosion protection.

Only 1.75” of GeoKrete was needed to achieve the structural requirements. For this application, it was spray applied and then troweled to a smooth finish. The Quadex team completed this portion of the project in one week.

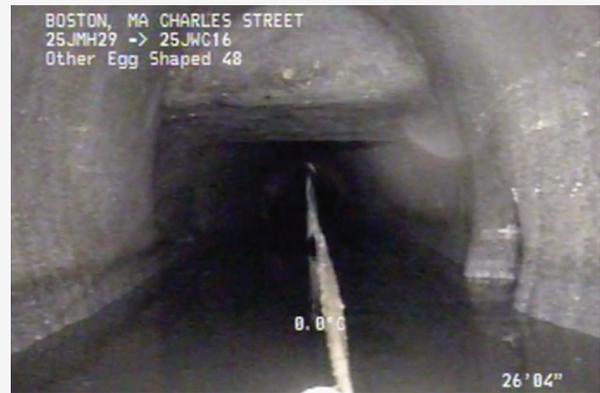
The Boston Water & Sewer Commission inspected the brick sewer one year after the project was completed. There were no visible signs of any degradation and was found to be in the same condition it was after the project was completed.

“Boston Water and Sewer Commission completed a one year post inspection of the West Side Interceptor and the GeoKrete Geopolymer liner is still in the same condition as the day it was installed. The Commission is pleased with the work done by Quadex Lining Systems to structurally rehabilitate this interceptor sewer.” — Irene McSweeney, Boston Water and Sewer Commission

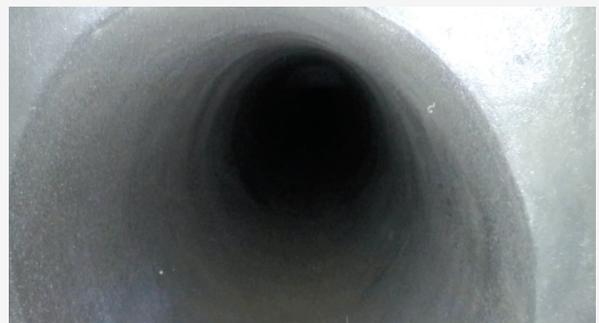
GeoKrete is precision applied in uniform thickness — resulting in a smooth, fully structural finish.
