GeoKrete® Geopolymer Restores Failing Corrugated Metal Pipes Damaged by Hurricane Harvey, Prevents Potential Collapse

**CMP CULVERTS RUNNING
BENEATH BUSY ROADWAY FULLY
STRUCTURALLY RESTORED
USING COMPLETELY TRENCHLESS
GEOPOLYMER SOLUTION**

Hurricane Harvey - Clay Road, Houston, Texas

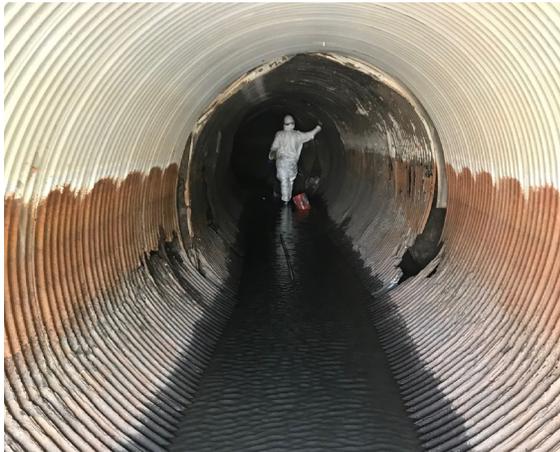
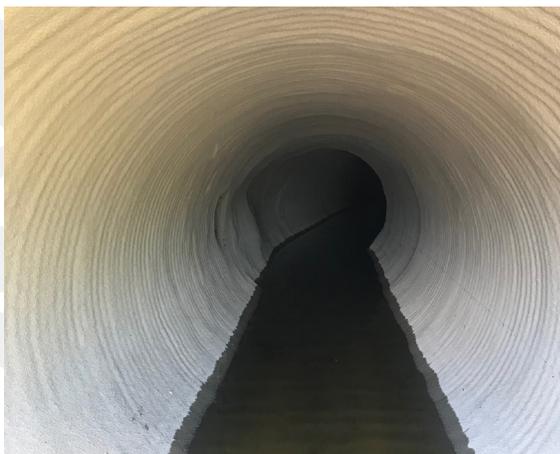
The City of Houston's post-storm inspections discovered a three-pipe culvert system beneath a stretch of Clay Road – a highly traveled, multi-lane commuter artery – had begun to fail. Large sections of the CMP (corrugated metal pipes) inverts exhibited corrosion, extreme degradation and wide pipe joint separations, while some sections were missing entirely. The extremely compromised pipes put Clay Road at risk of collapse.

Following standard F1216 practices, the design took all three loads (soil, hydrostatic, traffic) on the roadway into account. Prior to application, accumulated silt and debris were removed and surfaces were cleaned using a 3,500 psi pressure wash. Inverts were sealed with Vortex's Quadex® Quad-Flow, a quick-setting flowable high-strength repair mortar. Standard cementitious material and GeoKrete were used to fill pipe voids. GeoKrete was spray applied into open joints to fill and seal cavities, creating a monolithic structure.

The geopolymer was applied utilizing hand troweling, hand spraying and centrifugal methods to meet the diverse needs of each pipe section.

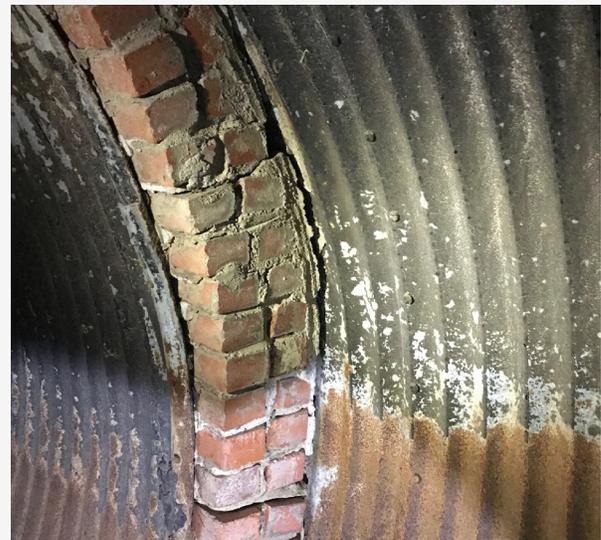
The versatility of GeoKrete allows it to be sprayed, spun or trowel applied over obstructions and unique shapes within a structure.

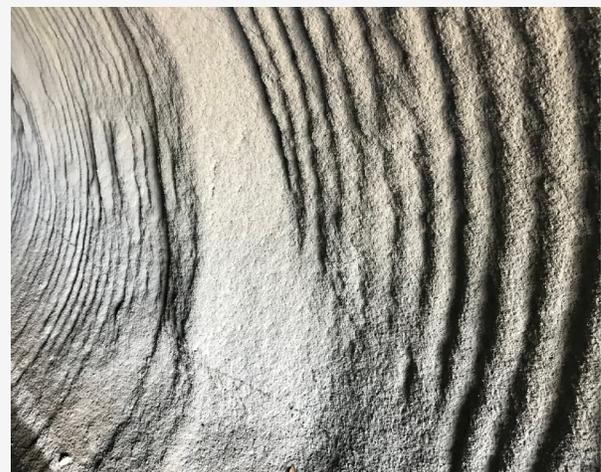
GeoKrete bonds tenaciously to multiple surfaces such as brick, CMP, concrete and clay.
