CASE STUDY

Vortex I & I Guard®-SSF Stops Soil Erosion and Preserves Seawall

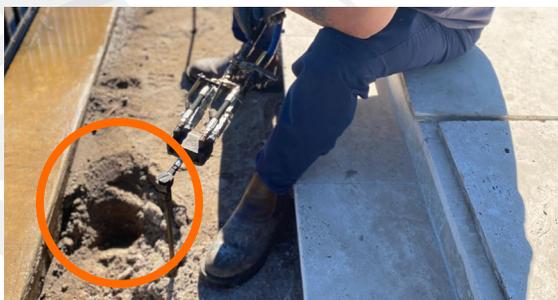
As technician injects I&I Guard - SSF into void behind seawall, signs of soil erosion were evident.
