# Geopolymer Lining System Used to Structurally Rehabilitate Deteriorated 60-Inch Sewer Pipe Running Beneath Metrorail System in Houston, TX

**COMPLETELY TRENCHLESS SOLUTION ALLOWED STREET AND LIGHT RAIL TO REMAIN OPERATIONAL THROUGHOUT DURATION OF PROJECT.**

## PROJECT SNAPSHOT

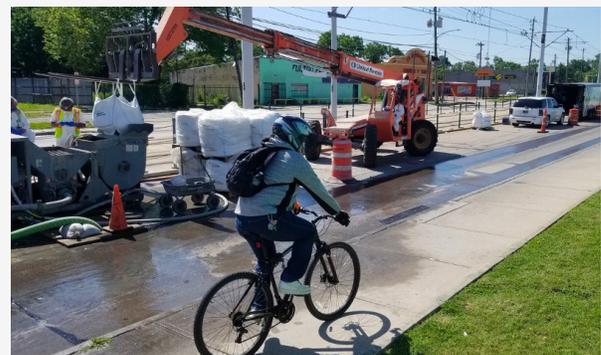
*Vortex was able to rehabilitate the 60" sanitary sewer line running beneath a section of the City's light rail train tracks.*

After cleaning and extensive patch and repair of the leaking sewer line's cracks, voids and offset joints, Vortex applied GeoKrete geopolymer to a 1.5" design thickness. GeoKrete is formulated to provide excellent corrosion protection in high hydrogen sulfide environments and restore structural integrity, once fully cured.

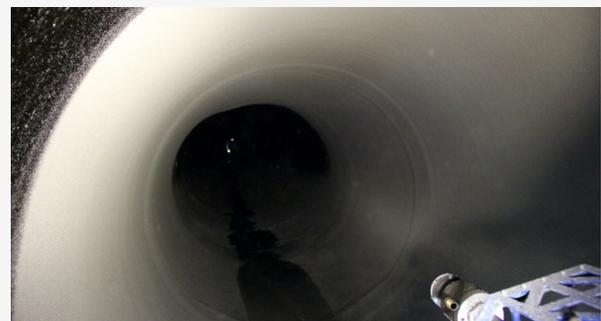
*Example of the QLS spin-casting process, where GeoKrete can be applied to a multitude of surfaces for superior corrosion protection and fully structural rehabilitation of the affected pipe or structure.*

Due to the versatility of the GeoKrete material, Vortex was able to both spray apply and spin-cast the material using application equipment.
