# Trenchless Technology Used to Rehabilitate Debilitated Infrastructure Under Four-Lane Highway in Appleton, WI

**GEOKRETE GEOPOLYMER MORTAR STRUCTURALLY RESTORES LEAKING AND CORRODED METAL ARCHED PIPE**

Outagamie County CTH CE Culvert Rehabilitation

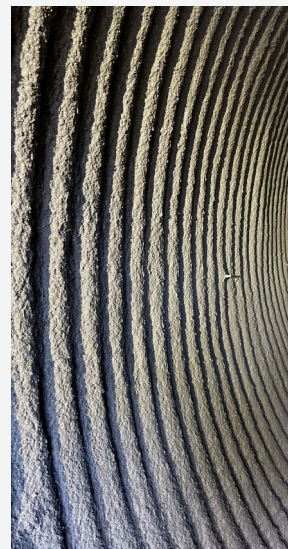
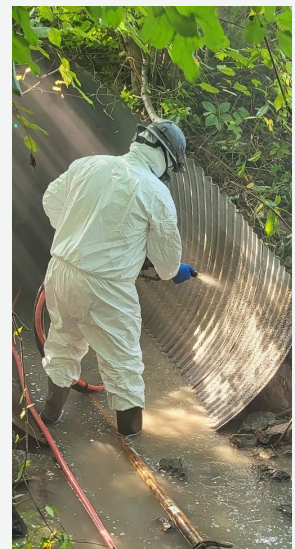
*The wall of the culvert before having GeoKrete geopolymer spray applied.*

VLS recommended GeoKrete be spray-applied to a thickness of 1.5" over the entire length of the pipe.

Vortex Lining Systems lined the existing pipe with the spray-applied GeoKrete Geopolymer. The application of the Geopolymer mortar not only seemingly solved the rust and deterioration issues for the pipe but upheld the structural integrity of the asset, adding 50 years of service life.

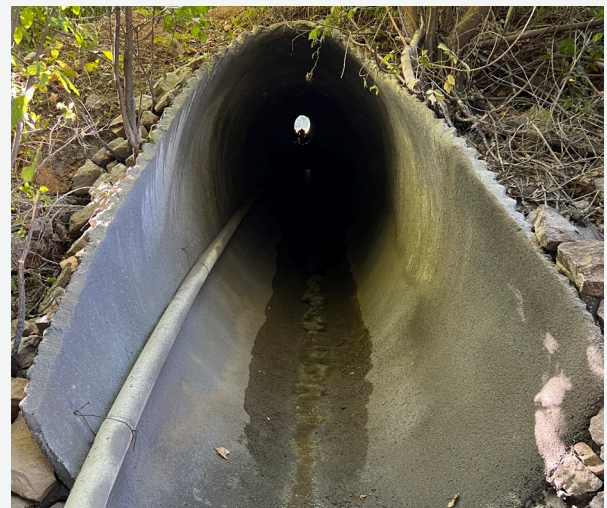
*The culvert pipe was fully rehabilitated due to the innovative and efficient spray-on application of GeoKrete geopolymer.*
