CASE STUDY

Geopolymer Lining System Used to Structurally Rehabilitate Deteriorated 60-Inch Sewer Pipe Running Beneath Metrorail System in Houston, TX

COMPLETELY TRENCHLESS SOLUTION ALLOWED STREET AND LIGHT RAIL TO REMAIN OPERATIONAL THROUGHOUT DURATION OF PROJECT.

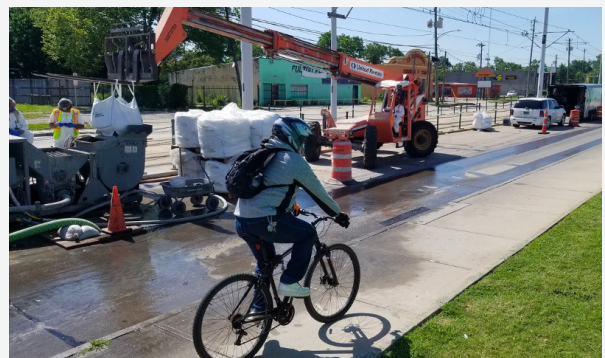
Vortex was able to rehabilitate the 60" sanitary sewer line running beneath a section of the City's light rail train tracks.

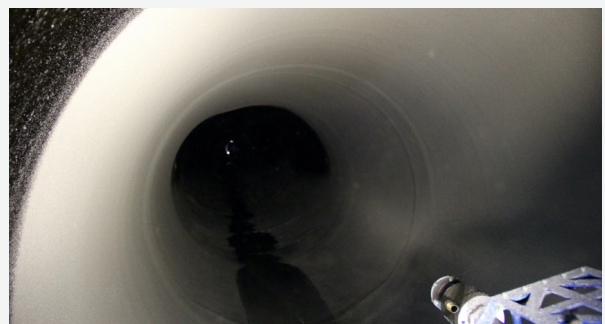
Example of the QLS spin-casting process, where GeoKrete can be applied to a multitude of surfaces for superior corrosion protection and fully structural rehabilitation of the affected pipe or structure.

Due to the versatility of the GeoKrete material, Vortex was able to both spray apply and spin-cast the material using application equipment.
