CASE STUDY

BREVARD COUNTY, FL — SOUTH BEACHES SEWER AND MANHOLE LINING INSTALLATION

County searching for manhole repair solution to stop infiltration, restore structural integrity.

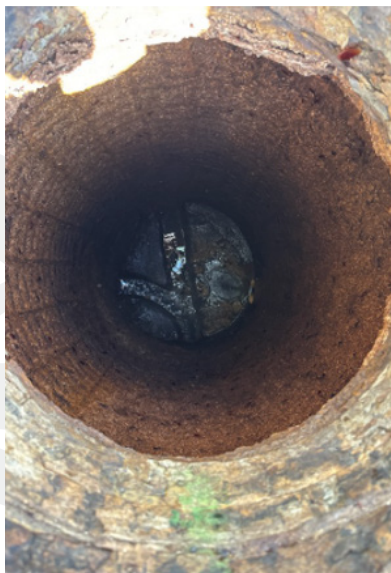
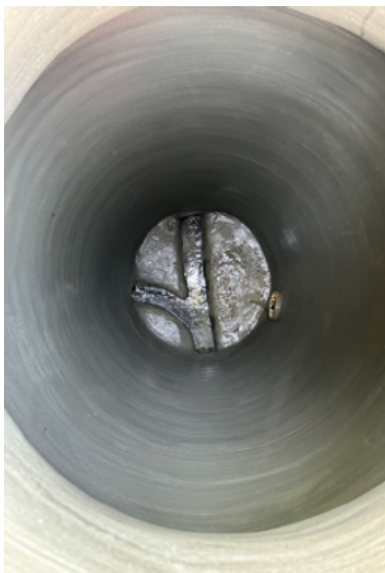
186 aging and deteriorating manholes suffering from partial blockage and I&I.

To ensure a long-term rehab solution required to restore the structural integrity of the 186 affected manholes (total of 1500 VF) manhole preparation is key. The Vortex Services crew first used high-pressure water, sand blasting, and other mechanical methods to clean the manholes and remove any materials that hindered their functionality. I & I Guard®-SCF 200 polyurethane injection grout was then used to seal off large cracks and voids, while I & I Guard®-PRF polyurethane grout was injected to stop high-flow infiltration.

Finally ready for lining, the team then spray-applied the manholes with Quadex® GeoKrete® geopolymer. In addition to restoring structural integrity, GeoKrete is extremely corrosion resistant, even during high exposure to hydrogen sulfide.

To address I&I in the manhole chimney sections, the team installed Chimney Guard™ Epoxy Urethane Hybrid, a flexible and durable chimney seal. In manholes where the corrosive environment was more aggressive, a topcoat of Structure Guard® 100% solids epoxy, which is known for its extreme corrosion resistance, was applied.
